Foretravel Bulkhead Repair-- A Comprehensive Look

This is on a 1993 U240, but applies to Unibody and Unicoaches.

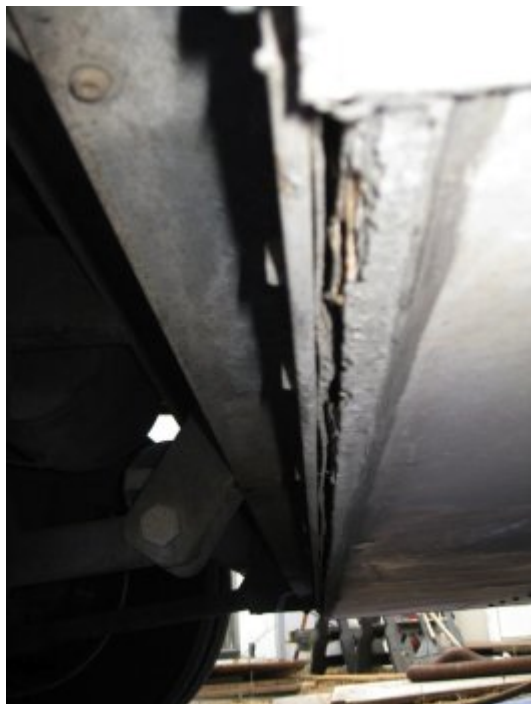
What I found was that 5 Rolok bolt "heads with 4 threads" pulled out IMMEDIATELY—at less than 20 inch-lbs. All the rest did not move at 250. In inspecting the failed Roloks, all had been broken for a long time – light surface rust on the sheared surface. The "4 threads" mean they were broken where they started torquing into the 1 1/2" beam. Could have been broken at installation or from sheer stress afterwards – not sure it matters.

Two fixes: Either remove the broken bolt (soak with penetrating oil, double nut and back out from the INSIDE), drill to 3/8" and thru bolt **OR** drill a new 3/8" hole and install 3/8"X 3", Grade 8 bolts and nuts on either side of the "failed" Roloks. Yes, you can use shorter ones, but the 3" ones made the job a little easier. Because I wanted to be able to torque the thru-bolts to 275 in-lbs without taking any chance of crushing the box beam, I made some 1 3/8" X 1 3/8"1/8" plates to install next to the beam (cost me a piece of steel and \$10 at a machine shop). So on the rear, from the rear: the 3/8" bolt, washer, 1/4" angle, 1 1/2" bulkhead, 1 3/8X 1 3/8X 1/8" plate, washer and pinch nut. All hardware grade 8 (except plate). Torque 275 in-lbs (again that's INCH not FOOT).
