Foretravel Bulkhead Repair-- A Comprehensive Look

By: Brett Wolf ... [Link to original article](#)

This is on a 1993 U240, but applies to Unibody and Unicoaches.

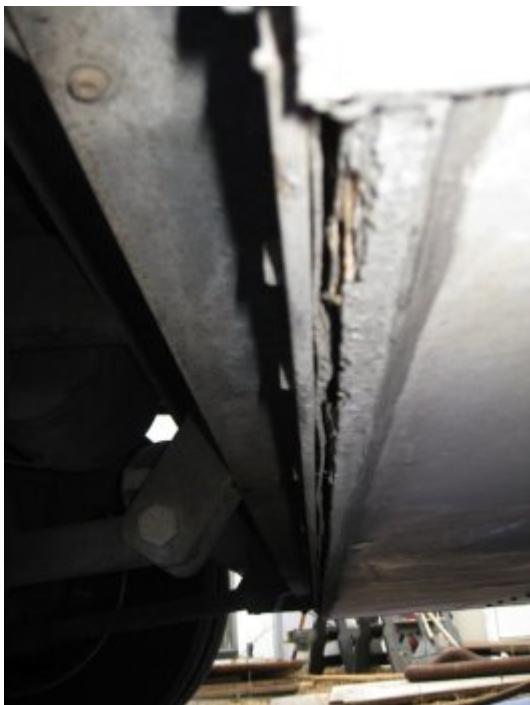
What I found was that 5 Rolok bolt "heads with 4 threads" pulled out IMMEDIATELY-at less than 20 inch-lbs. All the rest did not move at 250. In inspecting the failed Roloks, all had been broken for a long time - light surface rust on the sheared surface. The "4 threads" mean they were broken where they started torquing into the 1 1/2" beam. Could have been broken at installation or from sheer stress afterwards - not sure it matters.

Two fixes: Either remove the broken bolt (soak with penetrating oil, double nut and back out from the INSIDE), drill to 3/8" and thru bolt **OR** drill a new 3/8" hole and install 3/8"X 3", Grade 8 bolts and nuts on either side of the "failed" Roloks. Yes, you can use shorter ones, but the 3" ones made the job a little easier. Because I wanted to be able to torque the thru-bolts to 275 in-lbs without taking any chance of crushing the box beam, I made some 1 3/8" X 1 3/8"1/8" plates to install next to the beam (cost me a piece of steel and \$10 at a machine shop). So on the rear, from the rear: the 3/8" bolt, washer, 1/4" angle, 1 1/2" bulkhead, 1 3/8X 1 3/8X 1/8" plate, washer and pinch nut. All hardware grade 8 (except plate). Torque 275 in-lbs (again that's INCH not FOOT).
