# Foretravel Bulkhead Repair-- A Comprehensive Look

By: Brett Wolf ... [Link to original article](#)

This is on a 1993 U240, but applies to Unibody and Unicoaches.

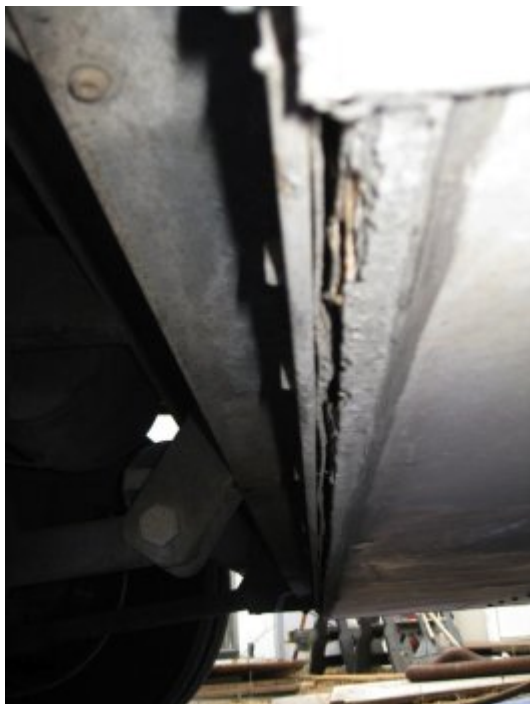
What I found was that 5 Rolok bolt "heads with 4 threads" pulled out IMMEDIATELY—at less than 20 inch-lbs. All the rest did not move at 250. In inspecting the failed Roloks, all had been broken for a long time – light surface rust on the sheared surface. The "4 threads" mean they were broken where they started torquing into the 1 1/2" beam. Could have been broken at installation or from sheer stress afterwards – not sure it matters.

Two fixes: Either remove the broken bolt (soak with penetrating oil, double nut and back out from the INSIDE), drill to 3/8" and thru bolt **OR** drill a new 3/8" hole and install 3/8"X 3", Grade 8 bolts and nuts on either side of the "failed" Roloks. Yes, you can use shorter ones, but the 3" ones made the job a little easier. Because I wanted to be able to torque the thru-bolts to 275 in-lbs without taking any chance of crushing the box beam, I made some 1 3/8" X 1 3/8"1/8" plates to install next to the beam (cost me a piece of steel and \$10 at a machine shop). So on the rear, from the rear: the 3/8" bolt, washer, 1/4" angle, 1 1/2" bulkhead, 1 3/8X 1 3/8X 1/8" plate, washer and pinch nut. All hardware grade 8 (except plate). Torque 275 in-lbs (again that's INCH not FOOT).
