Replacing Shower Skylight

<https://wiki.foreforums.com/> - **Foretravel Wiki**

<https://wiki.foreforums.com/technical:exterior:skylight>

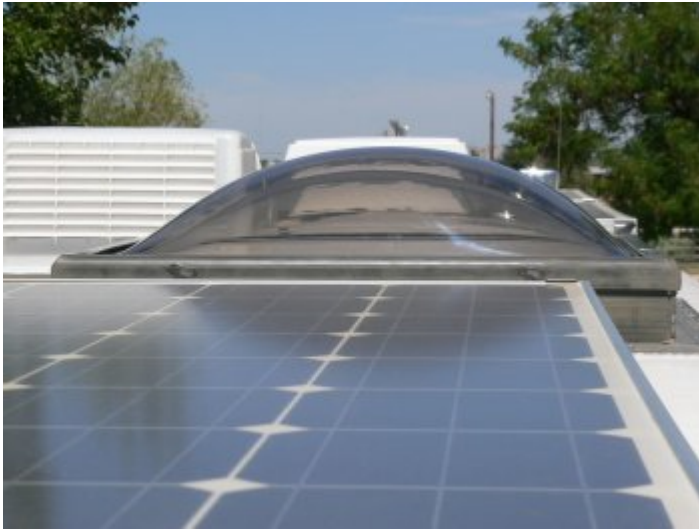
Inside our shower, the top white flat piece of plastic cracked and the outside smoked dome was damaged, so they both needed to be replaced.

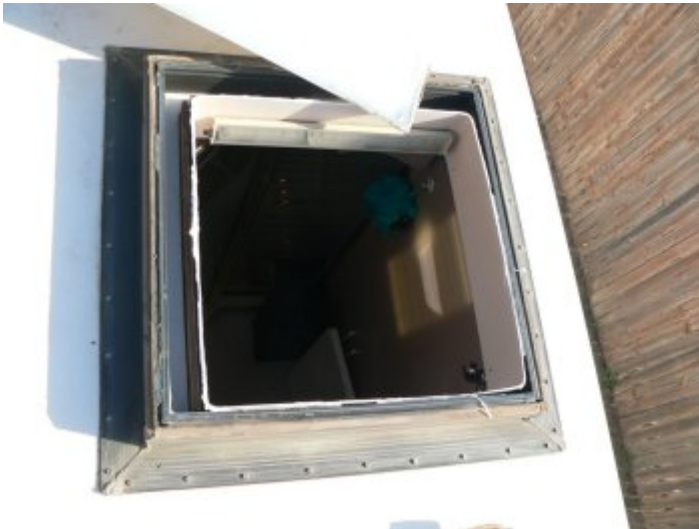
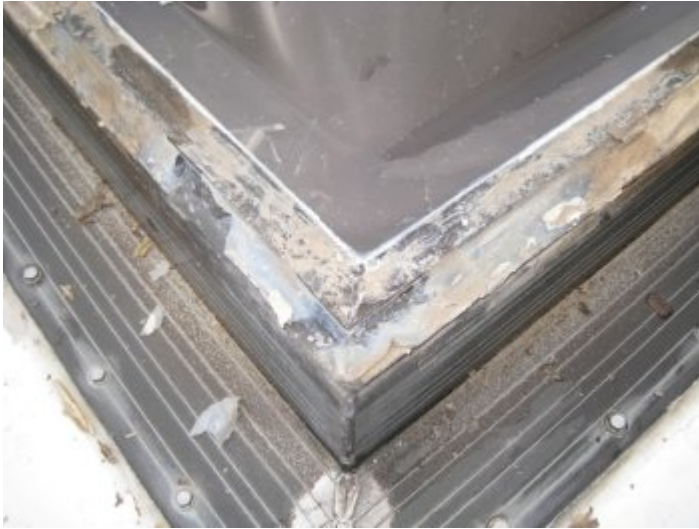
Original Skylight

Our original skylight base attached to the roof **should not** be removed or replaced. It has a perfect bottom flange that seals the base to the roof. The base is over 1-1/4" thick and has a removable top metal cover that protects the edges of the plastic parts. The cover is held in place with multiple short screws that fit into a well-designed weather protected gap all around the top of the base.

The original flat translucent white plastic panel that we see inside the shower is sealed to the top of the base. And the plastic outside dome is sealed to the top of the white translucent panel with the cover finishing the job.

Our square metal base measures 24-7/8". Our square plastic white flat and plastic dome measure 23-3/4".

Only the top pieces of plastic need to be replaced and most likely, replacement bases will probably not be as well engineered. Keeping the original base in place makes sure the inside trim can be reused as is.

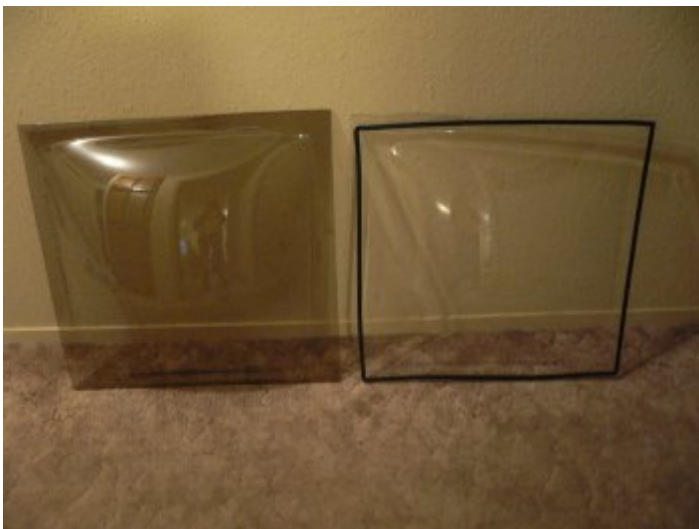
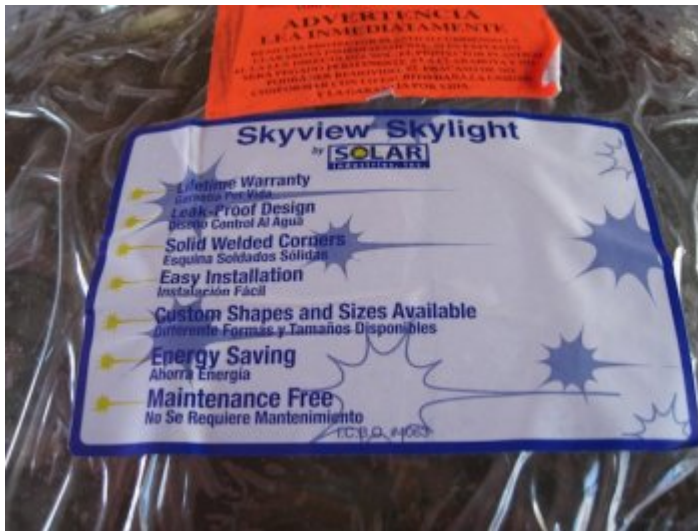
Replacement Skylight Domes

There are many ways to repair skylights and several Forum members offered good ideas. We found that Lowe's has a skylight with a removable smoked plastic dual-dome that fits our base. [Lowe's part number is 227698](#). We only used the plastic dome parts and scrapped the two base parts. Lowe's skylight does not come with a flat inside plastic.

This Lowe's skylight does not have the best made aluminum base and the domes are not attached with a weather tight seal, but the dual plastic domes, by themselves, are just what we need to replace our broken plastic parts.

The key to using the existing base is to find a replacement dome that measures 24" x 24" at the outside edge. Anything smaller will not work, one that is slightly larger might work with some trimming of the outer edges.

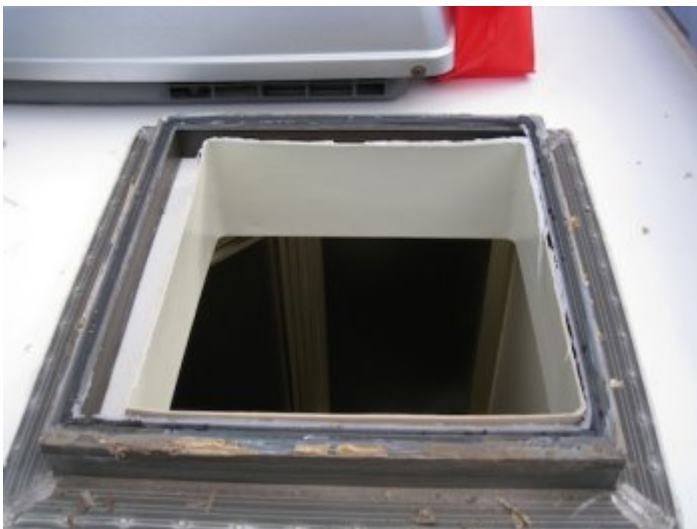
Replacement Flat Inside Plexiglass

Because the skylight frame is not spaced evenly around the opening in the roof, the amber tinted bubble cannot seal properly against the trim on the inside of the shower. It touches the trim on two sides, but there is a big gap on the other two sides. To bridge this gap, Foretravel installed the flat translucent inside panel. If they had mounted the skylight frame with the roof hole properly centered, the amber bubble would have sealed against the inside trim as it was designed. Of course, then you would get a lot more heat coming in because the dead air space between

the flat panel and the bubble would be missing.

Encore RV in Nacogdoches had pre-cut square pieces of 1/8" white translucent Plexiglas that we purchase earlier this year when our shower top piece first cracked. Unfortunately Encore is no longer in business so we need to find an alternative supplier.

I have located a outfit that will sell a single piece of 24" x 24" solid sheet material for a reasonable price, including shipping. They offer a pretty good selection, in a wide range of thickness and color. If all you want to do is reproduce the OEM factory skylight installation, then they can fix you up. They have a 1/8" thick white translucent Plexiglas panel that would be a perfect replacement for the original interior shower panel. Pair this with the Lowe's 2-piece skylight kit, and you would be good to go!

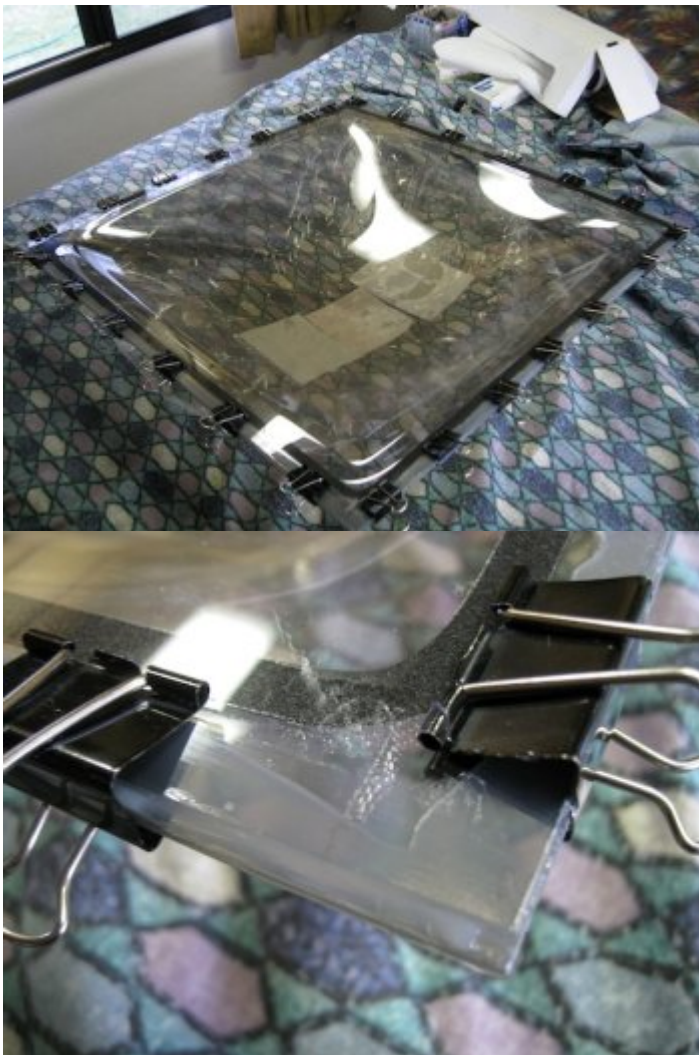
Sealing Domes and Flat Parts Together

It's been reported that some sealants may not hold up to the heat, for example GE 100% Silicone 2+ Clear.

It is supposed to have a service temp of -60F to 400F. It seemed to set up and cure properly when I stuck the two domes together in the house, but it obviously didn't like the heat on the coach roof. I pulled the domes apart and removed the failed sealant. So it's back to square 1 on putting the skylight assembly together.

We used denatured alcohol to prepare surfaces and GE Silicone II Supreme Clear to seal all parts together. First the two plastic domes were made air tight with a perimeter of silicone between the parts. After the silicone cured, we sealed the flat translucent Plexiglas to the bottom of the domes. Medium binder clips held parts together while curing.

An alternative to attach the two domes together is to try is 3M VHB mounting tape, it is black, not clear, but it should not matter because you can't see the tape looking up through the skylight from inside the shower stall.
