## Replacing transmission retarder valve

Allison Part #29552377 (this replaces earlier part #29547934)

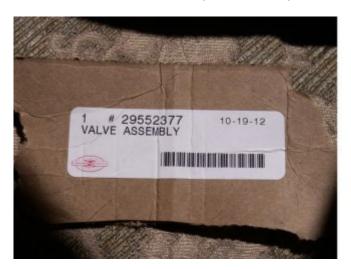
The Foretravel shop reported our retarder valve assembly was leaking quite a lot air. We decided not to replace it due to cost and advice from Alton that it probably was not necessary. The part, which they had in stock, was \$500.03.

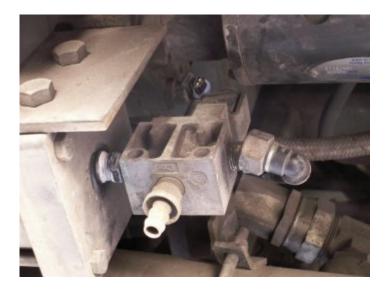
Removal is pretty easy; disconnect air supply line and the electrical connector.

Later, we found 3 of these available on eBay. Buy it Now for \$169.00 or Make Offer. Got one for \$130 plus \$6.85 shipping. Prior to removal of the old one I raised the coach and let it settle on supports between the frame and axles. Then bled air out of all tanks.

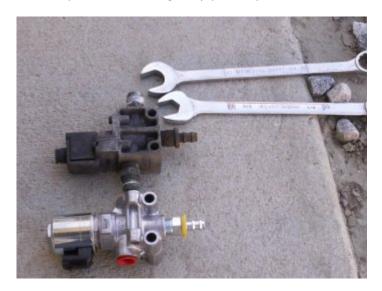
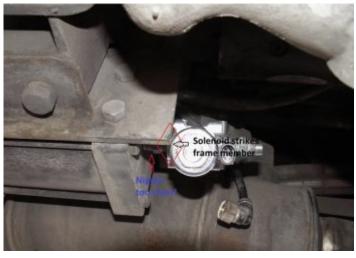
Then remove valve from retarder accumulator. Hardest part was cleaning old pipe compound from hardware threads.

The solenoid on the new assembly is a little wider than on the old one Part #29522717. As a result, reusing the old nipple did not work. I had to get something longer. Found a 3/8" x 2" nipple at the local auto parts store, which worked fine.

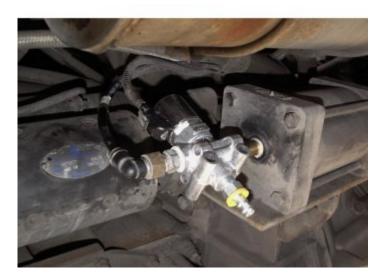
I used a TFE thread sealer. Tested for leaks with soapy solution; none found. Now we just have to confirm normal operation of the retarder on our next trip in a couple weeks.
