# Heater core replacement

I discovered a couple of weeks ago that the dash heater core on our 1999 U270 was leaking - saw slow drips out of the dash AC drain hose on the passenger side behind the upper corner of the generator door. I ordered a new one from FT, and got it replaced today. It was fairly straightforward to replace it, but there is a lot of stuff to remove to get to it. The good thing is that you can do it all inside the coach, standing or sitting, in air conditioned comfort (it was really hot outside today!) Here's a blow-by-blow, if you need to do it:

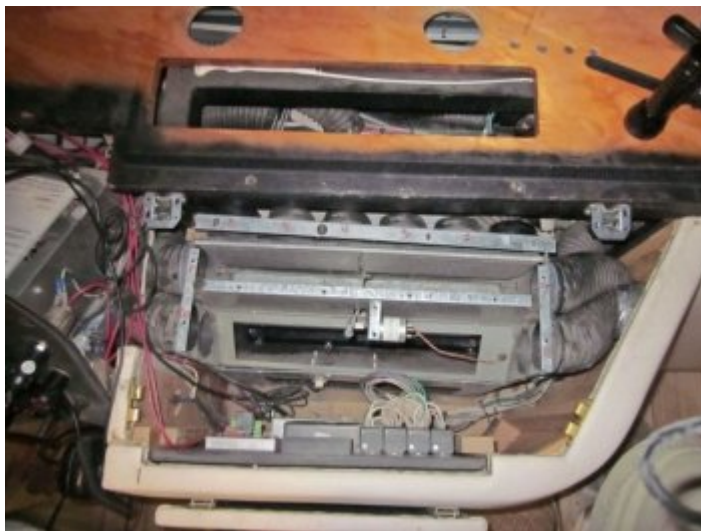
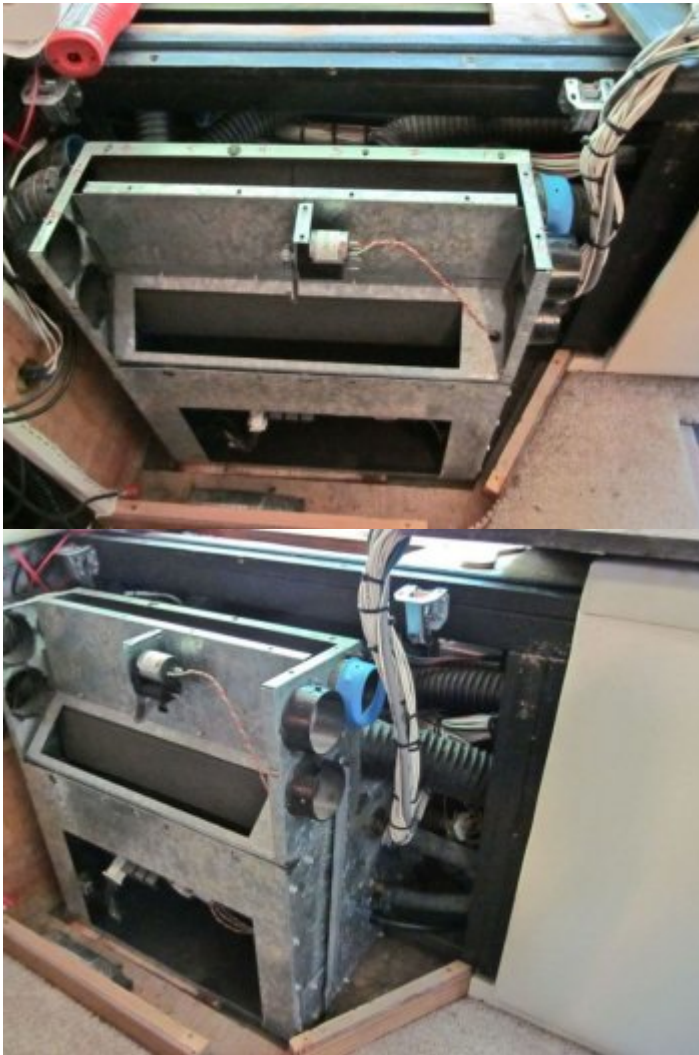
After loosening the box, it's simply a matter of removing many many screws holding the sheet metal pieces on and finally getting access to the top of the heater core which you can see through the flap opening after taking the first sheet metal cover off. You have to take the control levers off the flap motors, and lift out the two flap assemblies, so it's helpful to mark the flap positions before removing. (I forgot to do that, but it's not hard to figure out the right motor / flap positions by moving the controls to different settings and watching the motors.)

Finally, to remove the core, I took all the screws off the right side plate, and then detached the hoses (be prepared for more coolant draining!) and worked the core up from the left side.

New core went in the same way.
