Vacuum Generator Replacement

https://wiki.foreforums.com/technical:air_conditioning_system:dash:vacuum_generator_replacement

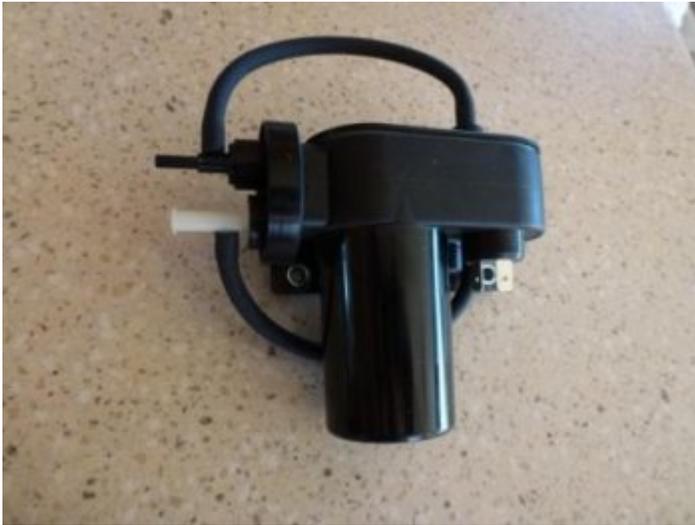
Our vacuum generator started leaking air a couple days ago inside it's little black box (located on passenger side of generator enclosure). It would drain the main air tanks in about 30 minutes. I talked to Bob at Foretravel and he said parts are no longer available for this, but they have a solution. They are sending me parts for about \$265.

The quick fix for the air leak was to fold the air supply line in half and tape it so it won't unfold. That is working. He said I won't need that air line because the new part is electric.

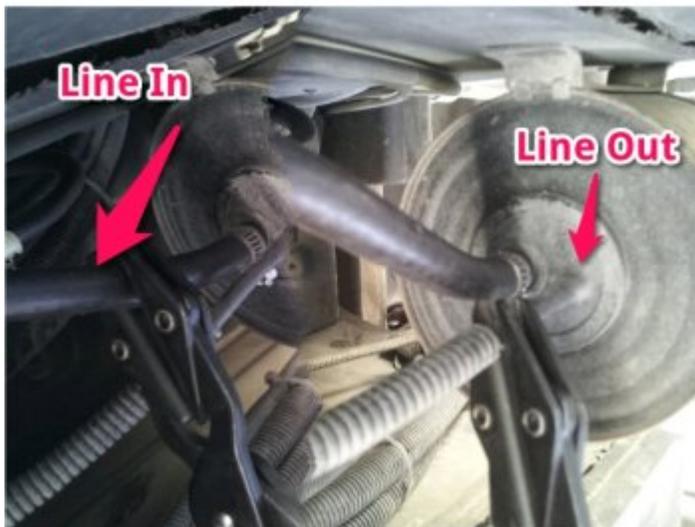
When I put my finger on the vacuum port, the pump shuts off immediately. Also, when I pinch off the vacuum tube into this can (see photo), pump shuts off, but when I pinch the tube "out", it keeps running.

The can is needed to support the stock vacuum generator. Without the can, the generator goes belly up very quickly.

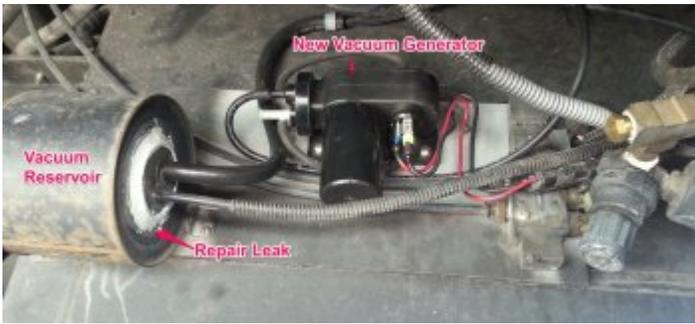
Vacuum Generator in and Reservoir repaired

Finally got this project finished. FOT no longer has a source for the vacuum reservoir; at least not now. The factory quit making them in about 2006. A neighbor suggested filling mine with water to see where it leaked. Found the leak and he gave me a marine epoxy sealant to fix it. Now the doors in the dash HVAC work again and no air leaks!

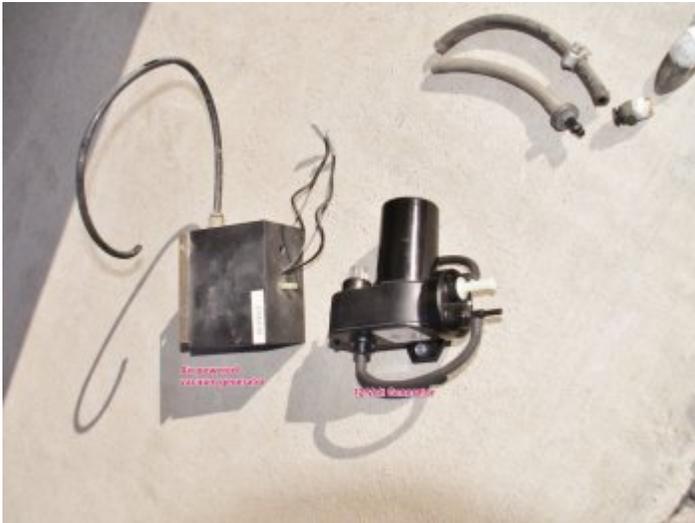
Old and New Vacuum Generator

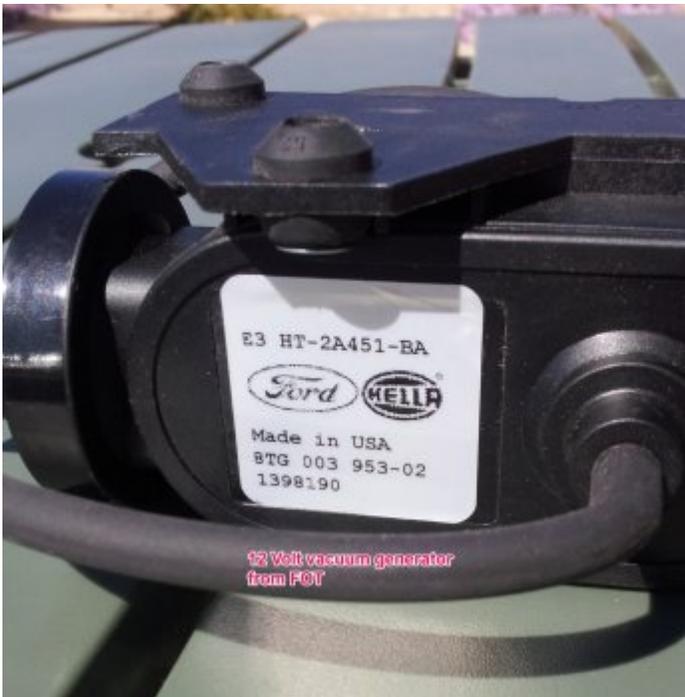
Part Number E3 HT-2A451-BA
Full topic by Dick S
