# 1988 thru 2005 Unibody Module/Subassembly (bulkhead) Inspection

This letter intends to clarify the process for properly inspecting the attachment points of the subassembly (sub floor) and the rear or front module of the Unihome or Unicoach chassis. The conditions addressed in this letter could pertain to year model coaches 1988 through 2005.

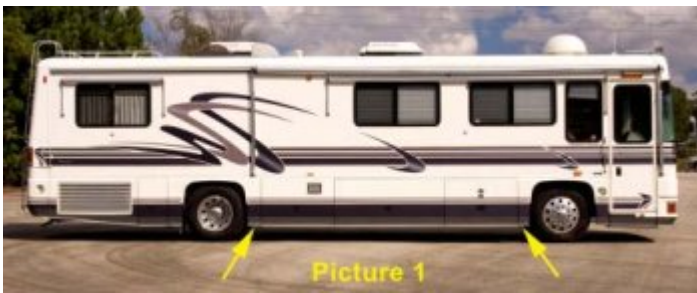
Picture 1

To inspect you will need to be able to look at the sub floor front and rear from underneath. (See Picture 1)

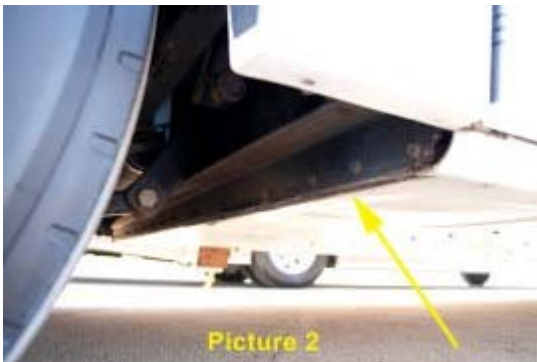
Picture 2

Inspect front and rear areas for any indication of separation of the transition seam from the front and rear module assembly to the sub floor assembly. (See Pictures 2, 3)

If there is evidence of rust, seam separation or missing fasteners, it is recommended to schedule a service appointment with us here in Nacogdoches or a trusted service facility of your choosing.
