1988 thru 2005 Unibody Module/Subassembly (bulkhead) Inspection

This letter intends to clarify the process for properly inspecting the attachment points of the subassembly (sub floor) and the rear or front module of the Unihome or Unicoach chassis. The conditions addressed in this letter could pertain to year model coaches 1988 through 2005.

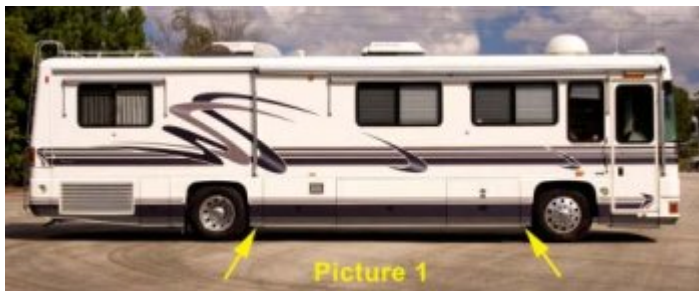
Picture 1

To inspect you will need to be able to look at the sub floor front and rear from underneath. (See Picture 1)

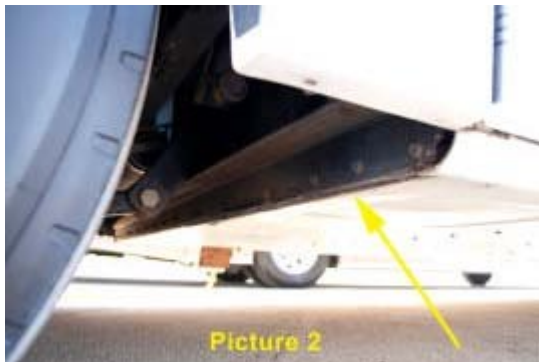
Picture 2

Inspect front and rear areas for any indication of separation of the transition seam from the front and rear module assembly to the sub floor assembly. (See Pictures 2, 3)

If there is evidence of rust, seam separation or missing fasteners, it is recommended to schedule a service appointment with us here in Nacogdoches or a trusted service facility of your choosing.
