1988 thru 2005 Unibody Module/Subassembly (bulkhead) Inspection

This letter intends to clarify the process for properly inspecting the attachment points of the subassembly (sub floor) and the rear or front module of the Unihome or Unicoach chassis. The conditions addressed in this letter could pertain to year model coaches 1988 through 2005.

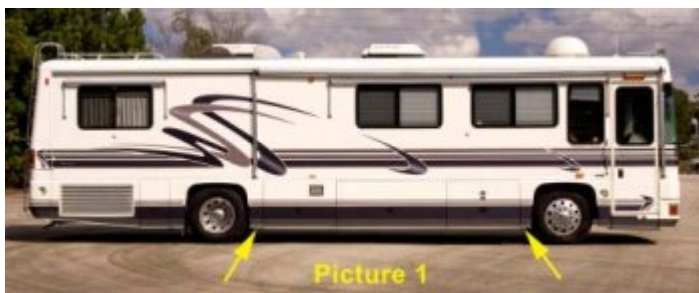
Picture 1

To inspect you will need to be able to look at the sub floor front and rear from underneath. (See Picture 1)
