# Ladder Repair - Plastic End Caps

We replaced all the plastic ends of our rear motorhome ladder. Many were cracked and some broken. Very dangerous to use ladder with broken parts. Those creaks when climbing ladder need to be heeded.

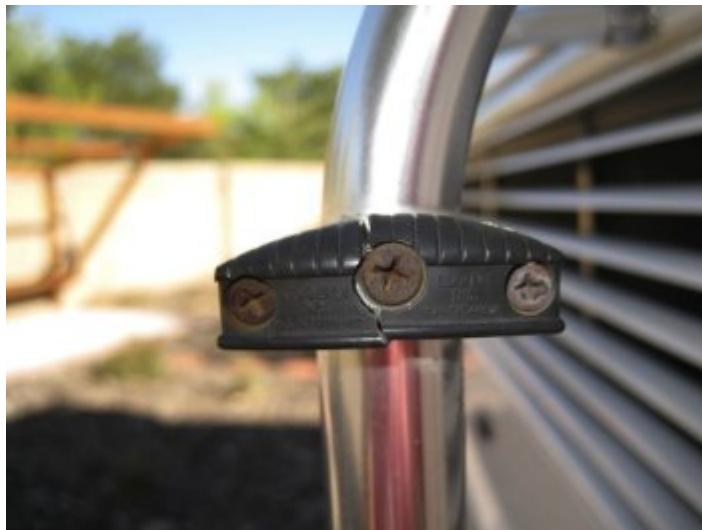
Broken step mounting before replacement. Very dangerous to use ladder with broken or cracked ends. Care must be taken to examine each step end and those creaks when climbing rear ladder should be taken seriously.

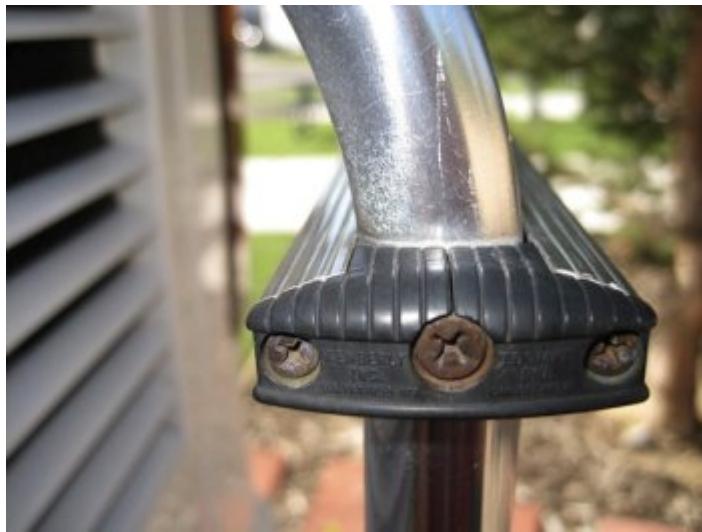
Cracked ends may be difficult to see. Crack usually happens in center.
