Ladder Repair - Plastic End Caps

We replaced all the plastic ends of our rear motorhome ladder. Many were cracked and some broken. Very dangerous to use ladder with broken parts. Those creaks when climbing ladder need to be heeded.

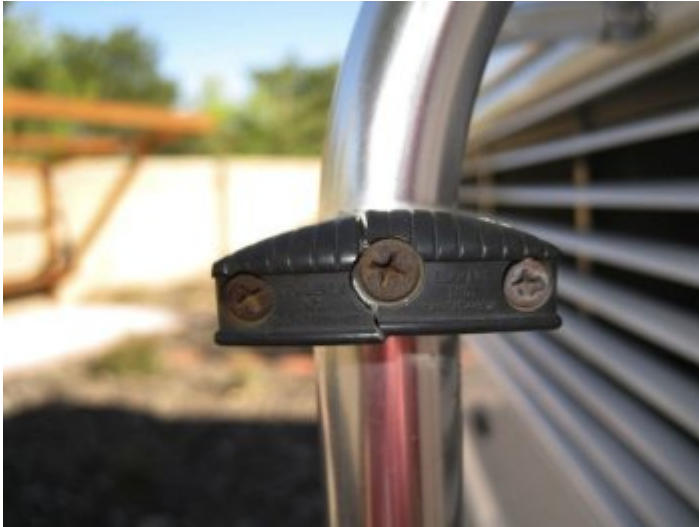
Broken step mounting before replacement. Very dangerous to use ladder with broken or cracked ends. Care must be taken to examine each step end and those creaks when climbing rear ladder should be taken seriously.

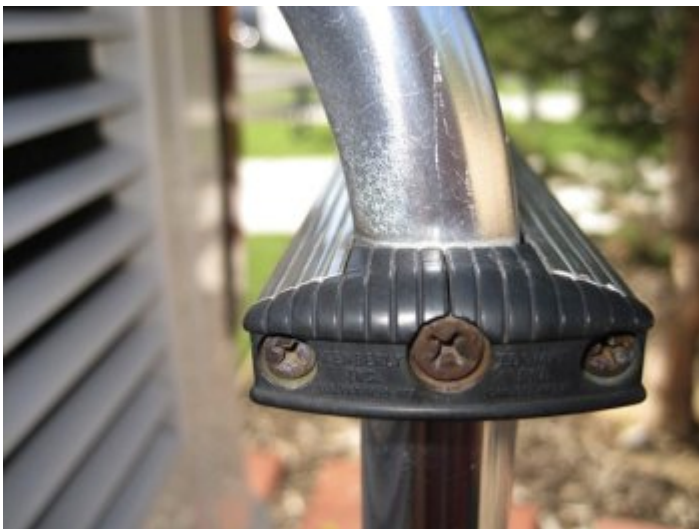
Cracked ends may be difficult to see. Crack usually happens in center.
