Ladder Repair - Plastic End Caps

We replaced all the plastic ends of our rear motorhome ladder. Many were cracked and some broken. Very dangerous to use ladder with broken parts. Those creaks when climbing ladder need to be heeded.

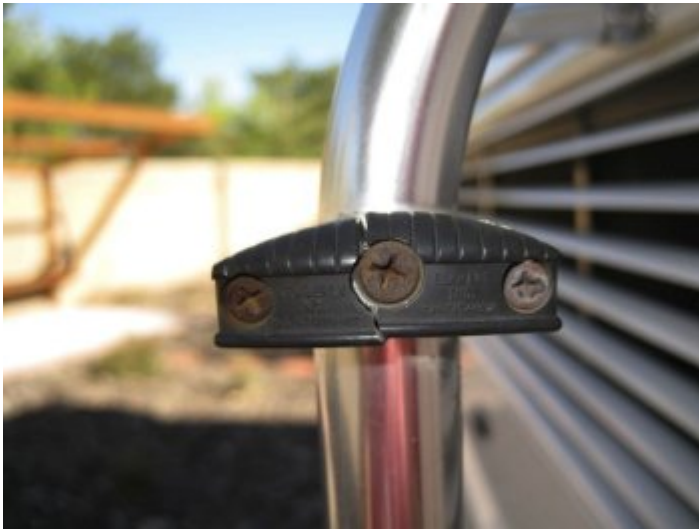
Broken step mounting before replacement. Very dangerous to use ladder with broken or cracked ends. Care must be taken to examine each step end and those creaks when climbing rear ladder should be taken seriously.

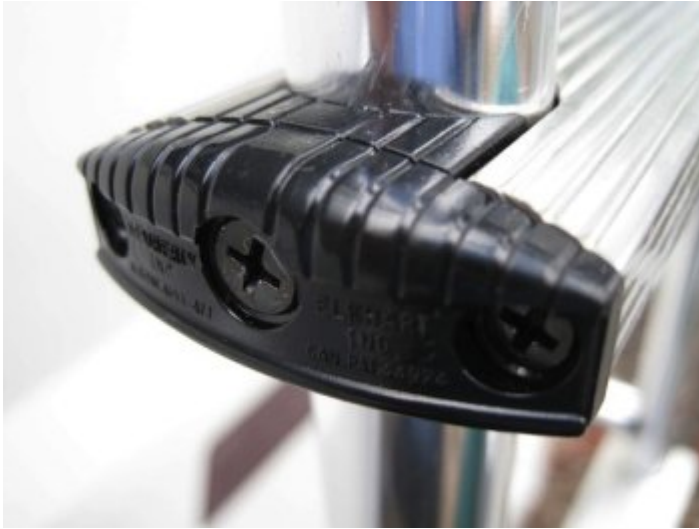
New step end. Note that it is the center screw that fastens each step end to the vertical part of the ladder attached to the motorhome. New center screw is self-drilling and care should be used to make a new inside hole if original was not straight. Outer hole is always reused. I found several original center screw holes were put in at an angle where they did not exit the ladder across from entry hole in ladder. I redirected new self-drilling screw and made a new straight hole. If you can find the same screw head which fits the ends, stainless would work ok.
