Replacing Shower Skylight

Inside our shower, the top white flat piece of plastic cracked and the outside smoked dome was damaged, so they both needed to be replaced.

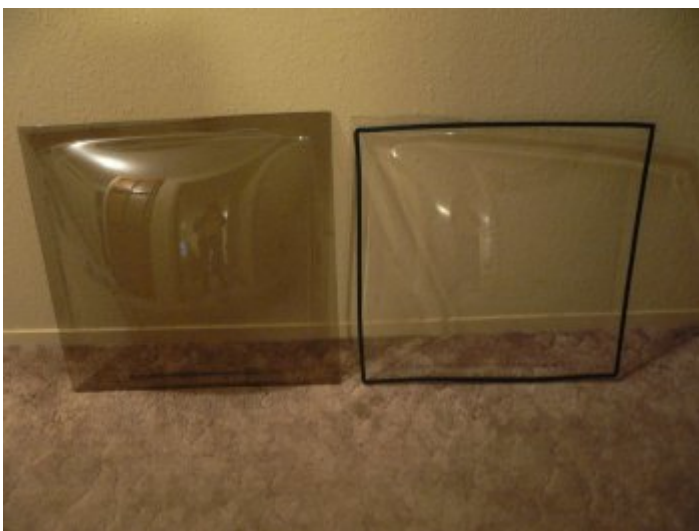
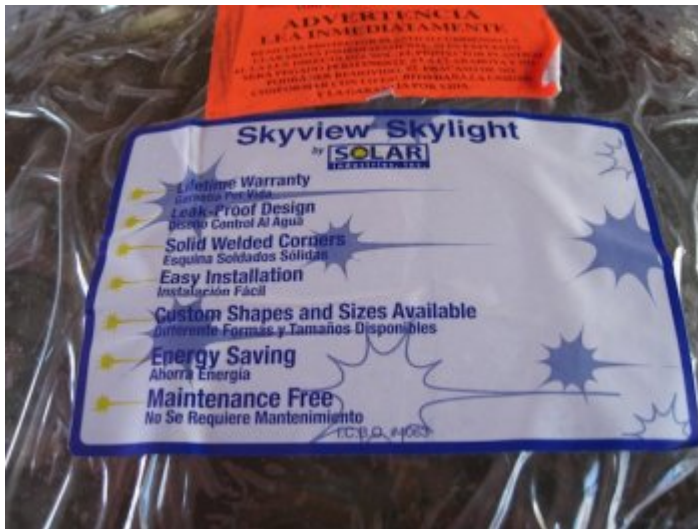
Replacement Skylight Domes

There are many ways to repair skylights and several Forum members offered good ideas. We found that Lowe's has a skylight with a removable smoked plastic dual-dome that fits our base. [Lowe's part number is 227698](#). We only used the plastic dome parts and scrapped the two base parts. Lowe's skylight does not come with a flat inside plastic.

This Lowe's skylight does not have the best made aluminum base and the domes are not attached with a weather tight seal, but the dual plastic domes, by themselves, are just what we need to replace our broken plastic parts.

The key to using the existing base is to find a replacement dome that measures 24" x 24" at the outside edge. Anything smaller will not work, one that is slightly larger might work with some trimming of the outer edges.

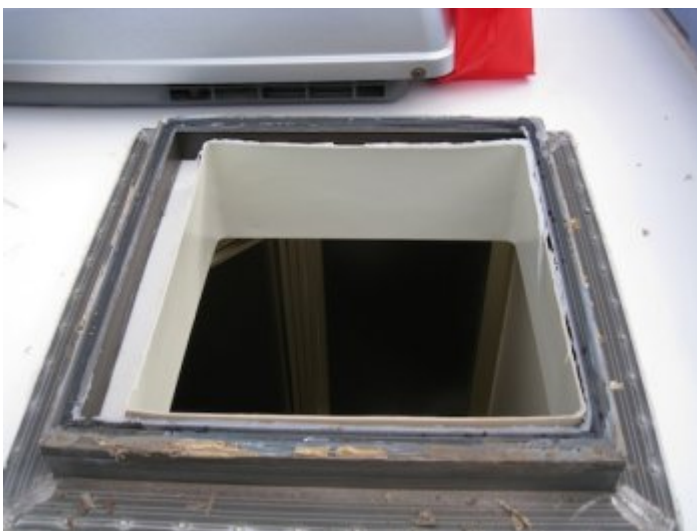
Replacement Flat Inside Plexiglass

Because the skylight frame is not spaced evenly around the opening in the roof, the amber tinted bubble cannot seal properly against the trim on the inside of the shower. It touches the trim on two sides, but there is a big gap on the other two sides. To bridge this gap, Foretravel installed the flat translucent inside panel. If they had mounted the skylight frame with the roof hole properly centered, the amber bubble would have sealed against the inside trim as it was designed. Of course, then you would get a lot more heat coming in because the dead air space between

the flat panel and the bubble would be missing.

Encore RV in Nacogdoches had pre-cut square pieces of 1/8" white translucent Plexiglas that we purchase earlier this year when our shower top piece first cracked. Unfortunately Encore is no longer in business so we need to find an alternative supplier.

I have located a outfit that will sell a single piece of 24" x 24" solid sheet material for a reasonable price, including shipping. They offer a pretty good selection, in a wide range of thickness and color. If all you want to do is reproduce the OEM factory skylight installation, then they can fix you up. They have a 1/8" thick white translucent Plexiglas panel that would be a perfect replacement for the original interior shower panel. Pair this with the Lowe's 2-piece skylight kit, and you would be good to go!
