Replacing Shower Skylight

Inside our shower, the top white flat piece of plastic cracked and the outside smoked dome was damaged, so they both needed to be replaced.

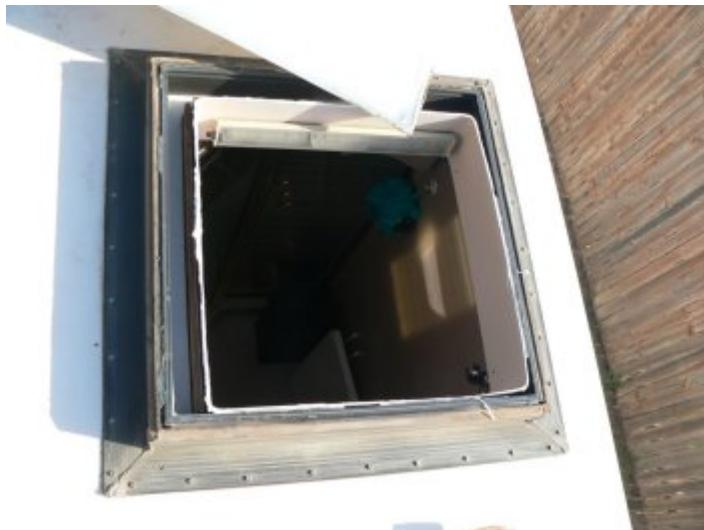
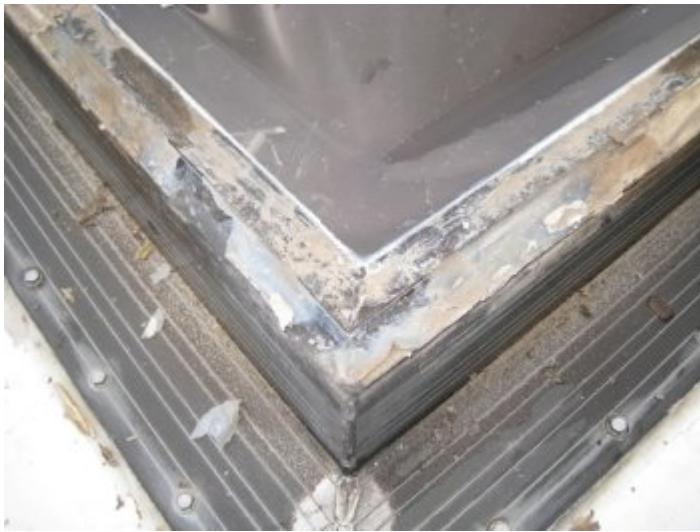
Original Skylight

Our original skylight base attached to the roof **should not** be removed or replaced. It has a perfect bottom flange that seals the base to the roof. The base is over 1-1/4" thick and has a removable top metal cover that protects the edges of the plastic parts. The cover is held in place with multiple short screws that fit into a well-designed weather protected gap all around the top of the base.

The original flat translucent white plastic panel that we see inside the shower is sealed to the top of the base. And the plastic outside dome is sealed to the top of the white translucent panel with the cover finishing the job.

Our square metal base measures 24-7/8". Our square plastic white flat and plastic dome measure 23-3/4".

Only the top pieces of plastic need to be replaced and most likely, replacement bases will probably not be as well engineered. Keeping the original base in place makes sure the inside trim can be reused as is.

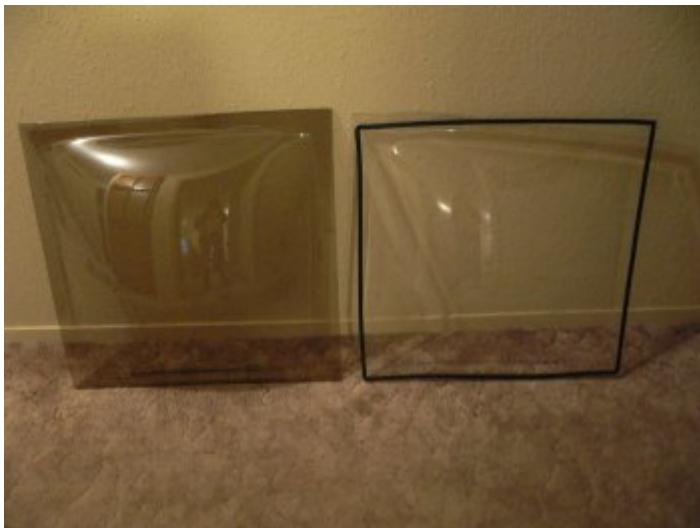
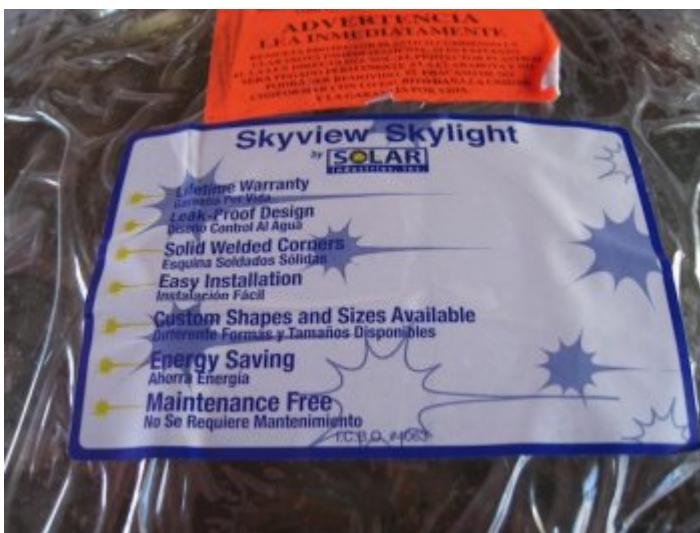
Replacement Skylight Domes

There are many ways to repair skylights and several Forum members offered good ideas. We found that Lowe's has a skylight with a removable smoked plastic dual-dome that fits our base. [Lowe's part number is 227698](#). We only used the plastic dome parts and scrapped the two base parts. Lowe's skylight does not come with a flat inside plastic.

This Lowe's skylight does not have the best made aluminum base and the domes are not attached with a weather tight seal, but the dual plastic domes, by themselves, are just what we need to replace our broken plastic parts.

The key to using the existing base is to find a replacement dome that measures 24" x 24" at the outside edge. Anything smaller will not work, one that is slightly larger might work with some trimming of the outer edges.

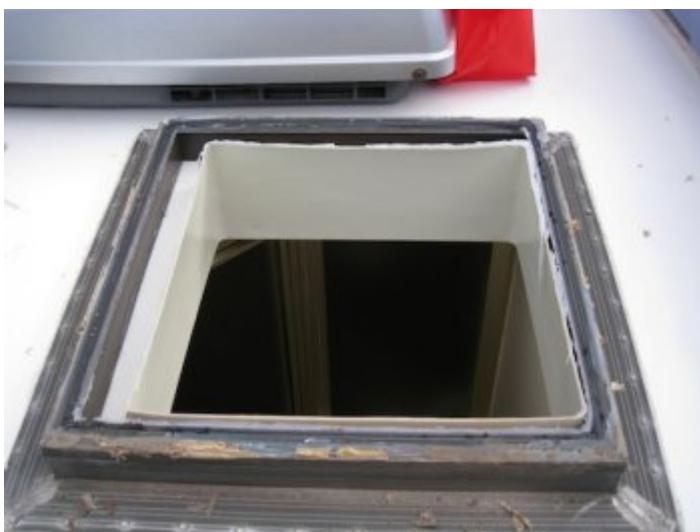
Replacement Flat Inside Plexiglass

Because the skylight frame is not spaced evenly around the opening in the roof, the amber tinted bubble cannot seal properly against the trim on the inside of the shower. It touches the trim on two sides, but there is a big gap on the other two sides. To bridge this gap, Foretravel installed the flat translucent inside panel. If they had mounted the skylight frame with the roof hole properly centered, the amber bubble would have sealed against the inside trim as it was designed. Of course, then you would get a lot more heat coming in because the dead air space between

the flat panel and the bubble would be missing.

Encore RV in Nacogdoches had pre-cut square pieces of 1/8" white translucent Plexiglas that we purchase earlier this year when our shower top piece first cracked. Unfortunately Encore is no longer in business so we need to find an alternative supplier.

I have located a outfit that will sell a single piece of 24" x 24" solid sheet material for a reasonable price, including shipping. They offer a pretty good selection, in a wide range of thickness and color. If all you want to do is reproduce the OEM factory skylight installation, then they can fix you up. They have a 1/8" thick white translucent Plexiglas panel that would be a perfect replacement for the original interior shower panel. Pair this with the Lowe's 2-piece skylight kit, and you would be good to go!

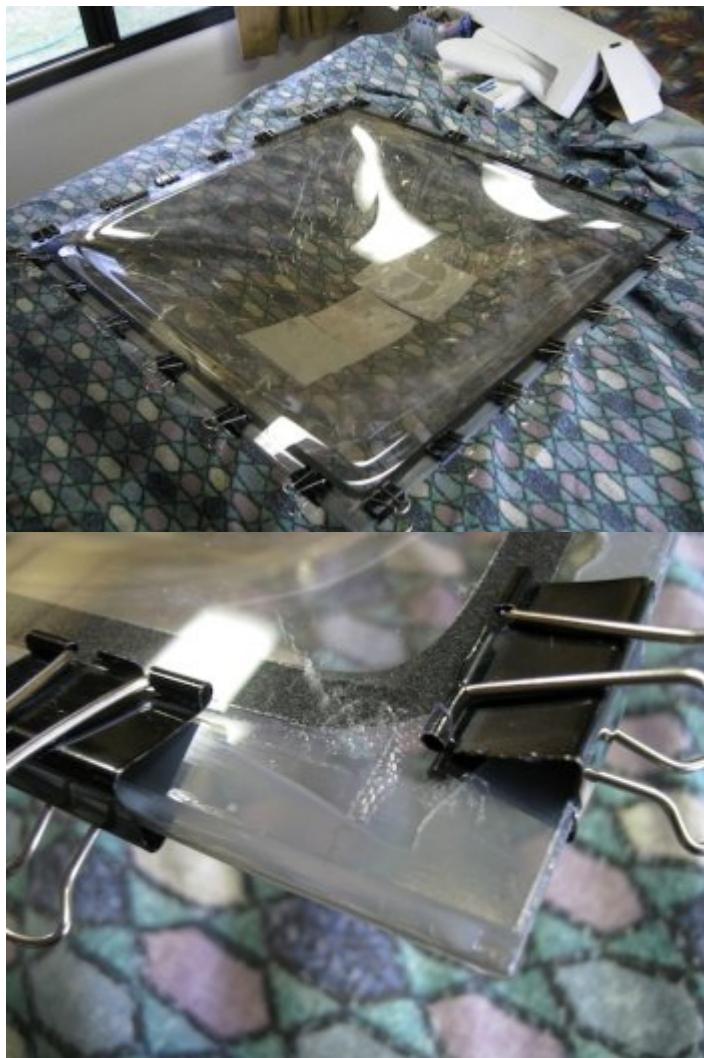
Sealing Domes and Flat Parts Together

We used denatured alcohol to prepare surfaces and GE Silicone II Supreme Clear to seal all parts together. First the two plastic domes were made air tight with a perimeter of silicone between the parts. After the silicone cured, we sealed the flat translucent Plexiglas to the bottom of the domes. Medium binder clips held parts together while curing.

It's been reported that some sealants may not hold up to the heat, for example GE 100% Silicone 2+ Clear.

It is supposed to have a service temp of -60F to 400F. It seemed to set up and cure properly when I stuck the two domes together in the house, but it obviously didn't like the heat on the coach roof. I pulled the domes apart and removed the failed sealant. So it's back to square 1 on putting the skylight assembly together.

An alternative to attach the two domes together is to try is 3M VHB mounting tape, it is black, not clear, but it should not matter because you can't see the tape looking up through the skylight from inside the shower stall.
