## **Retarder Accumulator Bracket Failure**

Foretravel has become aware of an issue where a weld on the transmission retarder accumulator mounting bracket may fail due to bracket damage or fatigue. The only **affected coaches are year model 1998 through 2007 with 450 or 500 hp Cummins M11 or ISM engines** having the retarder accumulator mounted to the engine bell housing.

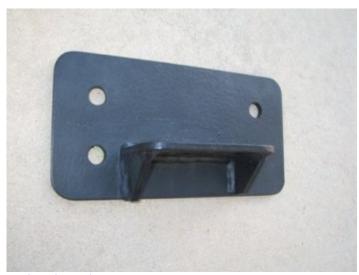
**Updated Bracket**

If non-warrantable replacement is needed the bracket (Part # P23439SVC) can be ordered directly from Foretravel Parts Dept. The approximate retail price of the bracket is \$67.00. It will take approximately 45 minutes to replace. The customer will be responsible for non-warrantable replacement parts and labor.

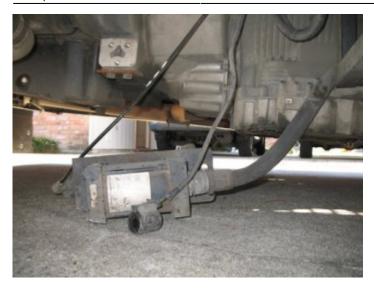
Bracket and Solenoid pieces dragging under coach. Also shows location of bracket attachment location above

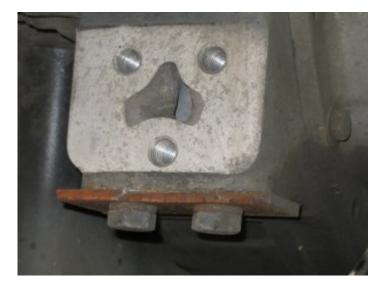
You should be able to see how easy this would be able to spot via inspection.

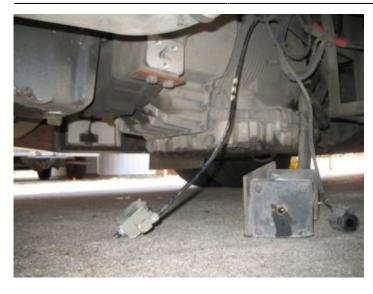
$\ensuremath{\mathsf{A}}$  better perspective of location of bracket.

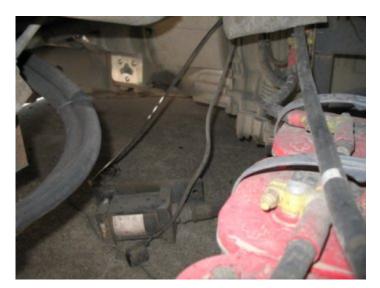
From the engine battery access door on curb side

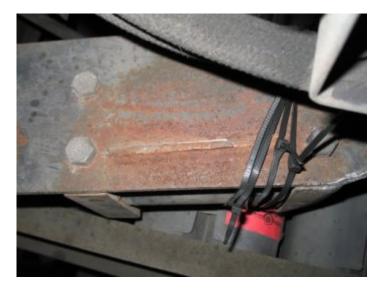
Shows where the metal fractured
