## **Retarder Accumulator Bracket Failure**

Foretravel has become aware of an issue where a weld on the transmission retarder accumulator mounting bracket may fail due to bracket damage or fatigue. The only **affected coaches are year model 1998 through 2007 with 450 or 500 hp Cummins M11 or ISM engines** having the retarder accumulator mounted to the engine bell housing.

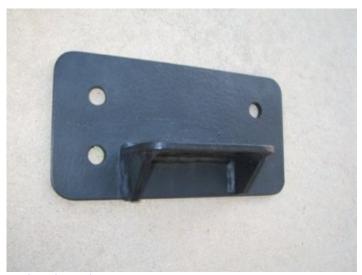
**Updated Bracket**

If non-warrantable replacement is needed the bracket (Part # P23439SVC) can be ordered directly from Foretravel Parts Dept. The approximate retail price of the bracket is \$67.00. It will take approximately 45 minutes to replace. The customer will be responsible for non-warrantable replacement parts and labor.

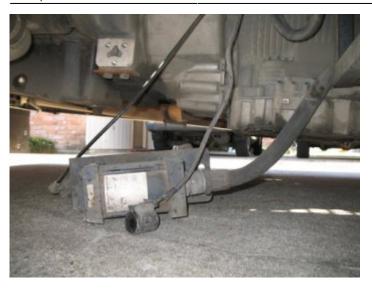
Bracket and Solenoid pieces dragging under coach. Also shows location of bracket attachment location above

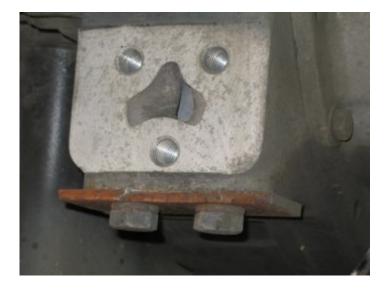
You should be able to see how easy this would be able to spot via inspection.

When these particular coaches are being serviced in your shop the bracket should be inspected for cracking or damage in the bottom weld area. It will take less than 15 minutes to inspect. As a courtesy, Foretravel will provide the inspection at no charge to the customer in your shop. If there are signs that the bracket should be replaced, and the coach is under warranty, Foretravel will supply a new mounting bracket and labor to replace at no charge to the customer. Call Foretravel Technical Services (936) 564-8367, extension 259 or 237 for prior approval before replacing bracket.

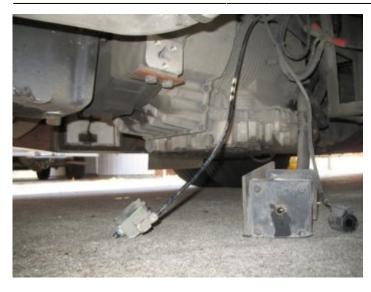
$\ensuremath{\mathsf{A}}$  better perspective of location of bracket.

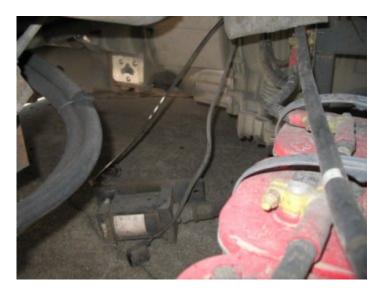
From the engine battery access door on curb side

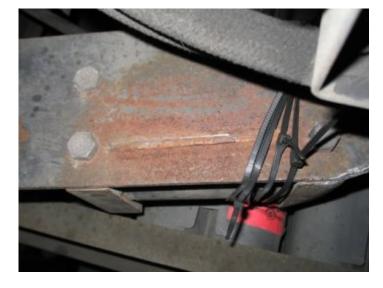
Shows where the metal fractured
