# Replacing transmission retarder valve

Allison Part #29552377 (this replaces earlier part #29547934)

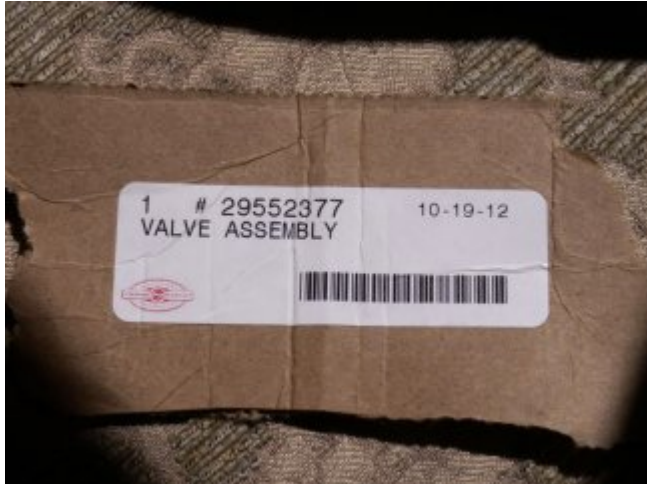
The Foretravel shop reported our retarder valve assembly was leaking quite a lot air. We decided not to replace it due to cost and advice from Alton that it probably was not necessary. The part, which they had in stock, was \$500.03.

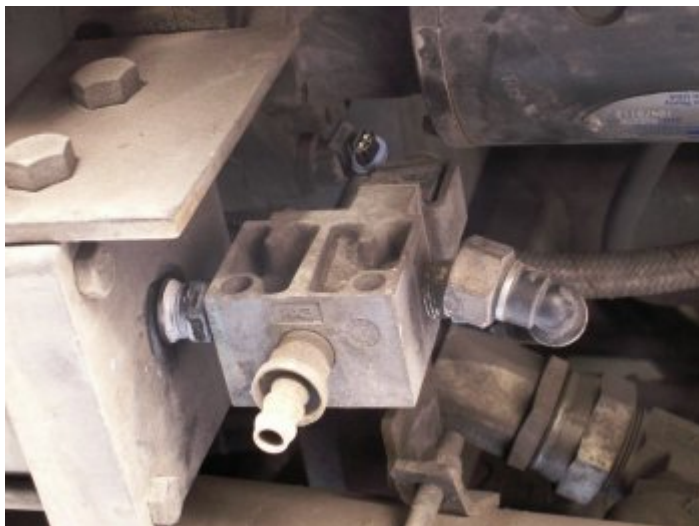
Later, we found 3 of these available on eBay. Buy it Now for \$169.00 or Make Offer. Got one for \$130 plus \$6.85 shipping. Prior to removal of the old one I raised the coach and let it settle on supports between the frame and axles. Then bled air out of all tanks.

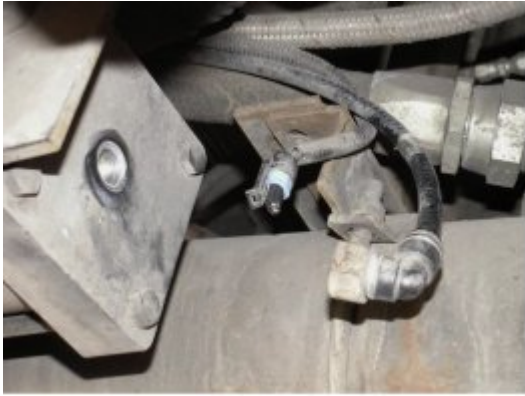
Removal is pretty easy; disconnect air supply line and the electrical connector.

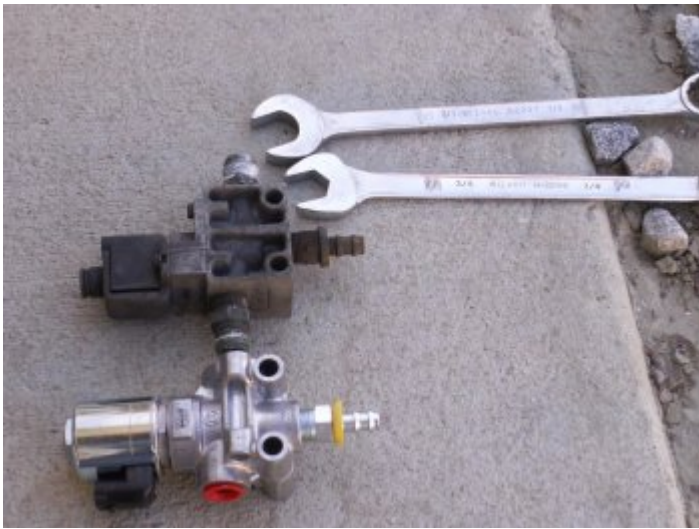
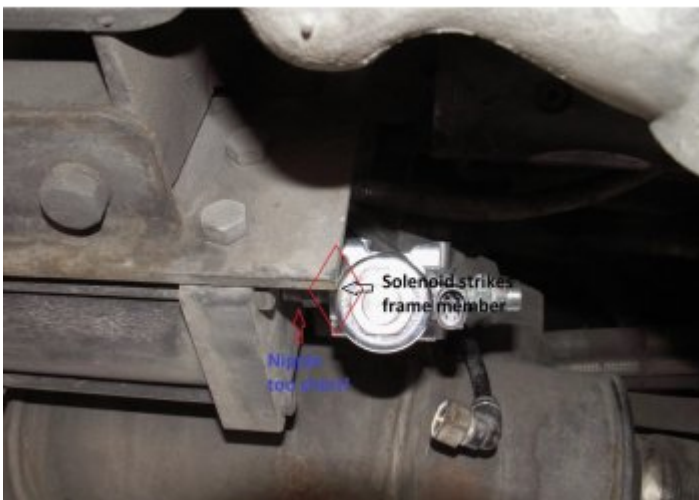
Then remove valve from retarder accumulator.  
Hardest part was cleaning old pipe compound from hardware threads.

The solenoid on the new assembly is a little wider than on the old one Part #29522717. As a result, reusing the old nipple did not work. I had to get something longer. Found a 3/8" x 2" nipple at the local auto parts store, which worked fine.

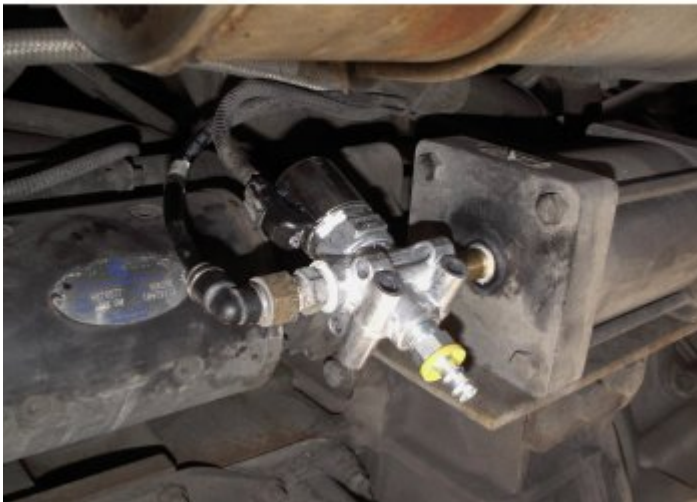
I used a TFE thread sealer. Tested for leaks with soapy solution; none found.  
Now we just have to confirm normal operation of the retarder on our next trip in a couple weeks.
