Retarder Accumulator Bracket Failure

Foretravel has become aware of an issue where a weld on the transmission retarder accumulator mounting bracket may fail due to bracket damage or fatigue. The only **affected coaches are year model 1998 through 2007 with 450 or 500 hp Cummins M11 or ISM engines** having the retarder accumulator mounted to the engine bell housing.

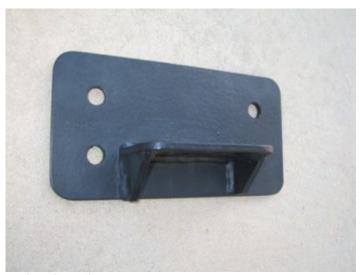
Updated Bracket

If non-warrantable replacement is needed the bracket (Part # P23439SVC) can be ordered directly from Foretravel Parts Dept. The approximate retail price of the bracket is \$67.00. It will take approximately 45 minutes to replace. The customer will be responsible for non-warrantable replacement parts and labor.

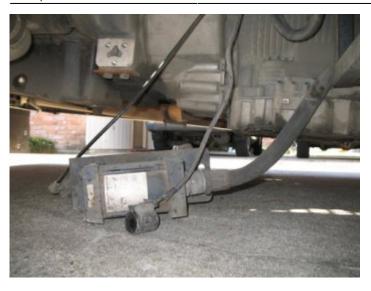
Bracket and Solenoid pieces dragging under coach. Also shows location of bracket attachment location above

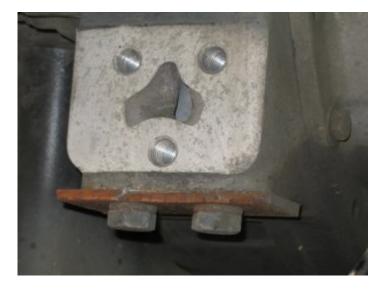
You should be able to see how easy this would be able to spot via inspection.

When these particular coaches are being serviced in your shop the bracket should be inspected for cracking or damage in the bottom weld area. It will take less than 15 minutes to inspect. As a courtesy, Foretravel will provide the inspection at no charge to the customer in your shop. If there are signs that the bracket should be replaced, and the coach is under warranty, Foretravel will supply a new mounting bracket and labor to replace at no charge to the customer. Call Foretravel Technical Services (936) 564-8367, extension 259 or 237 for prior approval before replacing bracket.

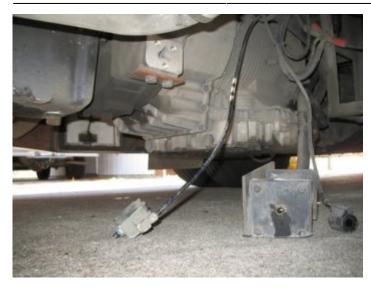
$\ensuremath{\mathsf{A}}$ better perspective of location of bracket.

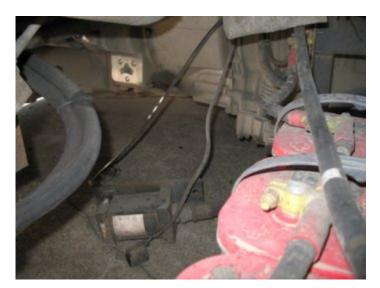
From the engine battery access door on curb side

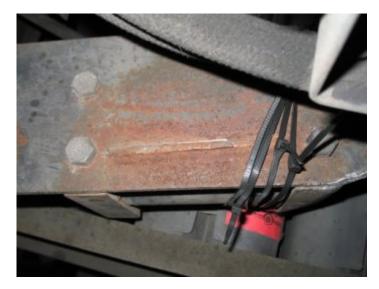
Shows where the metal fractured
