Heater core replacement

I discovered a couple of weeks ago that the dash heater core on our 1999 U270 was leaking - saw slow drips out of the dash AC drain hose on the passenger side behind the upper corner of the generator door. I ordered a new one from FT, and got it replaced today. It was fairly straightforward to replace it, but there is a lot of stuff to remove to get to it. The good thing is that you can do it all inside the coach, standing or sitting, in air conditioned comfort (it was really hot outside today!) Here's a blow-by-blow, if you need to do it:

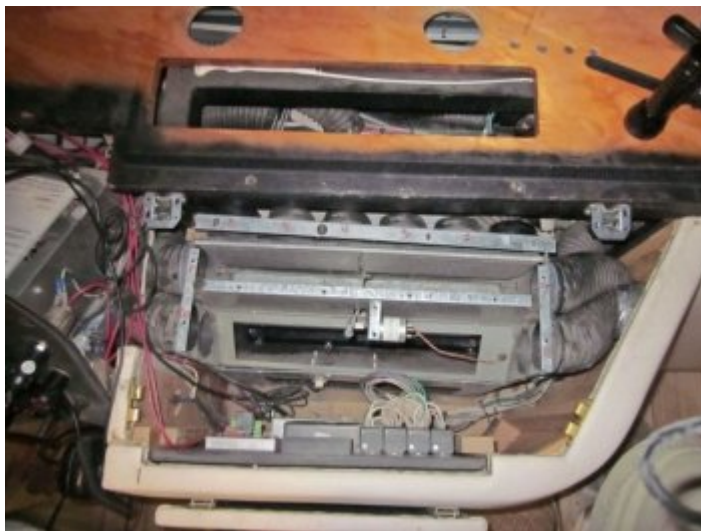
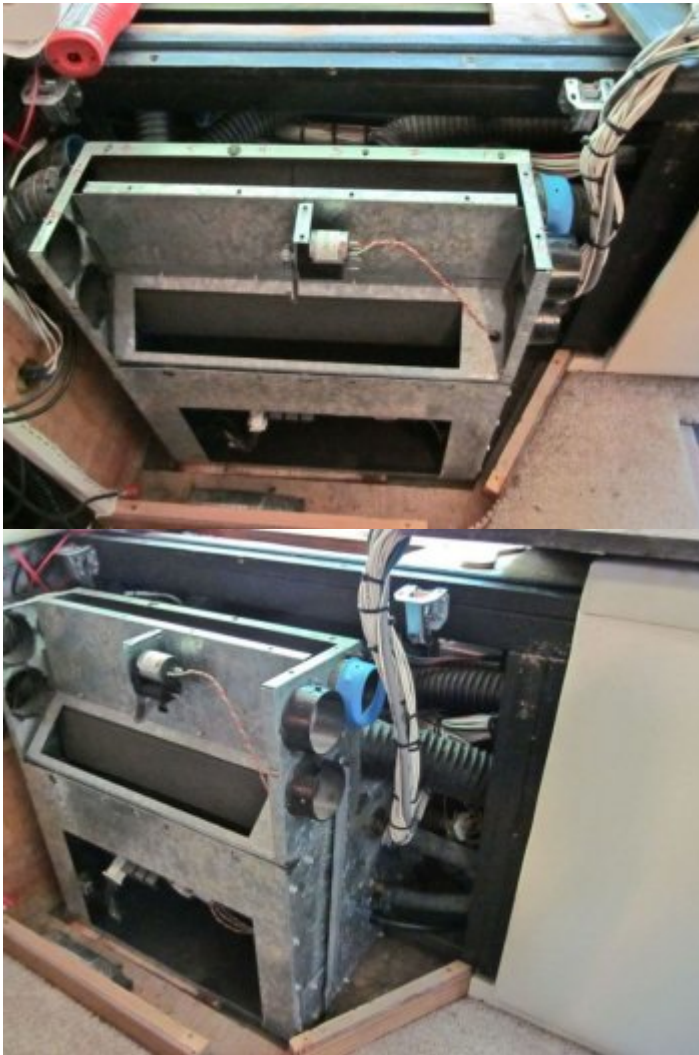
After loosening the box, it's simply a matter of removing many many screws holding the sheet metal pieces on and finally getting access to the top of the heater core which you can see through the flap opening after taking the first sheet metal cover off. You have to take the control levers off the flap motors, and lift out the two flap assemblies, so it's helpful to mark the flap positions before removing. (I forgot to do that, but it's not hard to figure out the right motor / flap positions by moving the controls to different settings and watching the motors.)

Finally, to remove the core, I took all the screws off the right side plate, and then detached the hoses (be prepared for more coolant draining!) and worked the core up from the left side.

New core went in the same way.
