Vacuum Generator Replacement

<https://wiki.foreforums.com/> - **Foretravel Wiki**

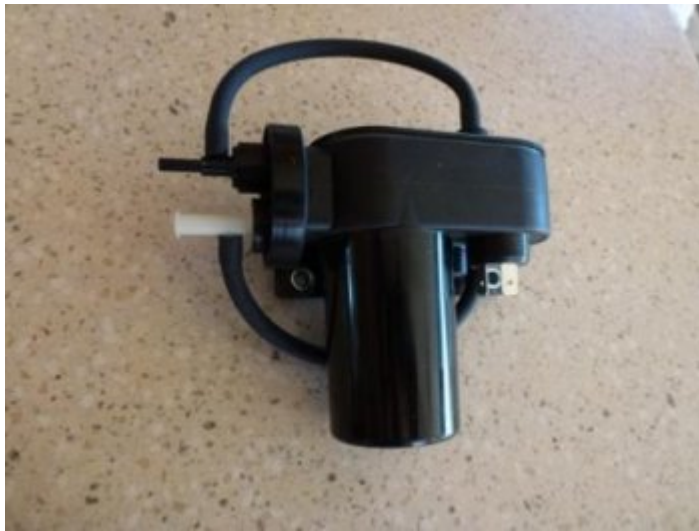
Our vacuum generator started leaking air a couple days ago inside its little black box (located on passenger side of generator enclosure). It would drain the main air tanks in about 30 minutes. I talked to Bob at Foretravel and he said parts are no longer available for this, but they have a solution. They are sending me parts for about \$265.

The quick fix for the air leak was to fold the air supply line in half and tape it so it won't unfold. That is working. He said I won't need that air line because the new part is electric.

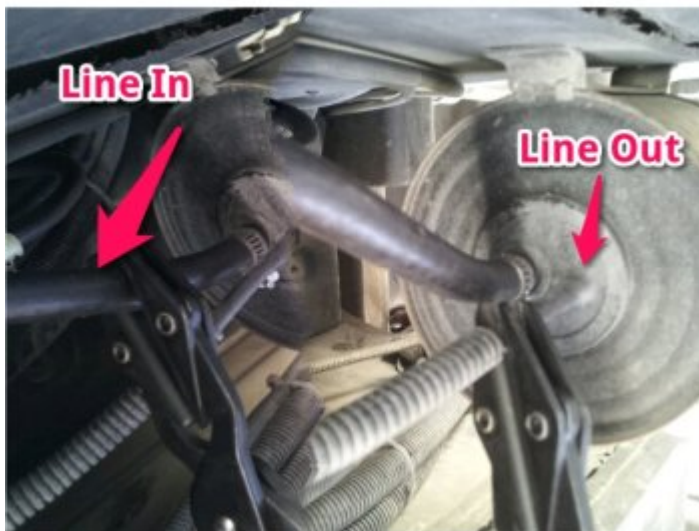
When I put my finger on the vacuum port, the pump shuts off immediately. Also, when I pinch off the vacuum tube into this can (see photo), pump shuts off, but when I pinch the tube "out", it keeps running.

The can is needed to support the stock vacuum generator. Without the can, the generator goes belly up very quickly.

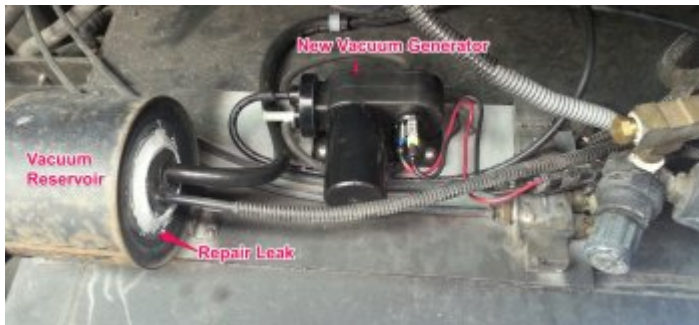
Vacuum Generator in and Reservoir repaired

Finally got this project finished. FOT no longer has a source for the vacuum reservoir; at least not now. The factory quit making them in about 2006. A neighbor suggested filling mine with water to see where it leaked. Found the leak and he gave me a marine epoxy sealant to fix it. Now the doors in the dash HVAC work again and no air leaks!

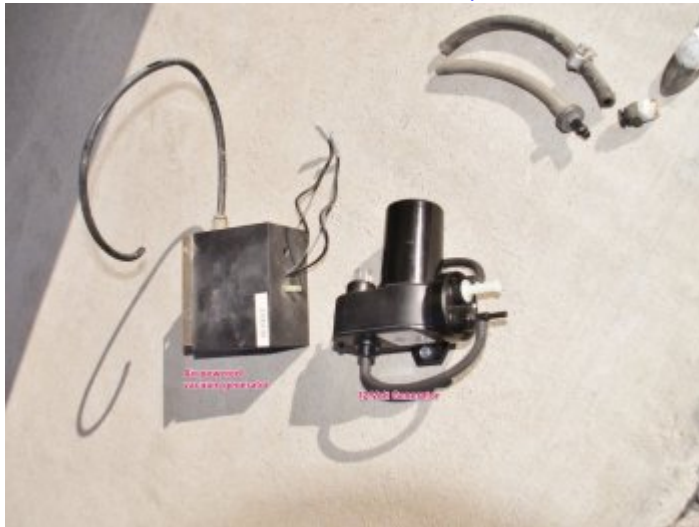
Old and New Vacuum Generator
