Air Bags Replaced - 1997 U270

by Barry and Cindy 1997 U270 36' 11/21/13 ... This document originally appeared on BeamAlarm and was recreated from a copy on the wayback machine

We had our 17-year-old air bags replaced.

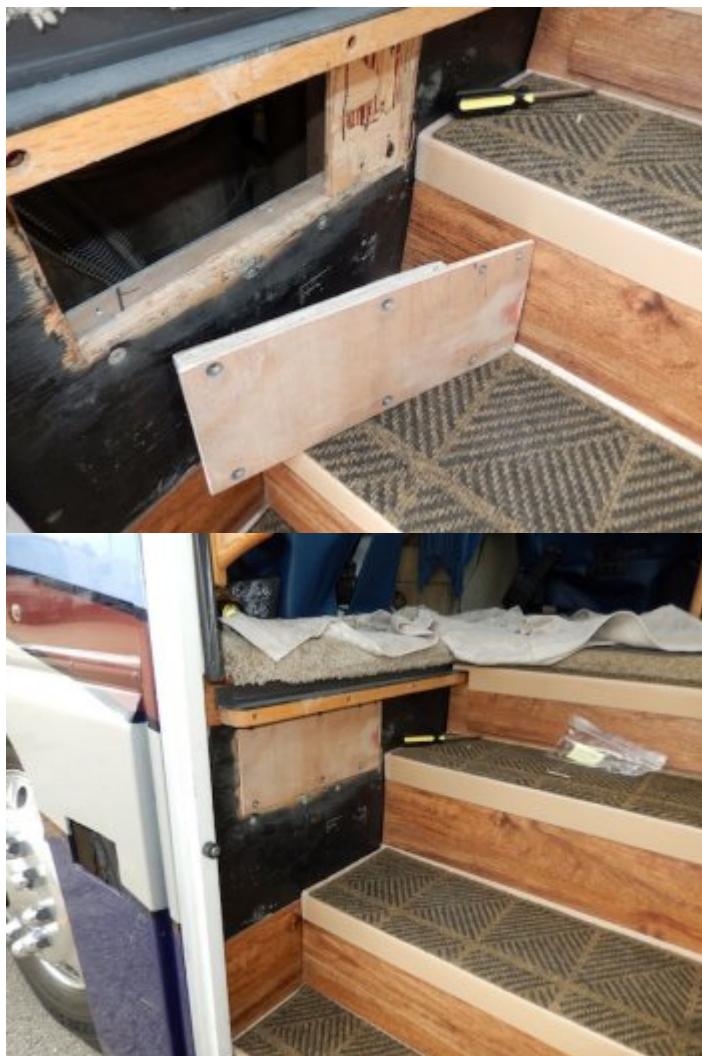
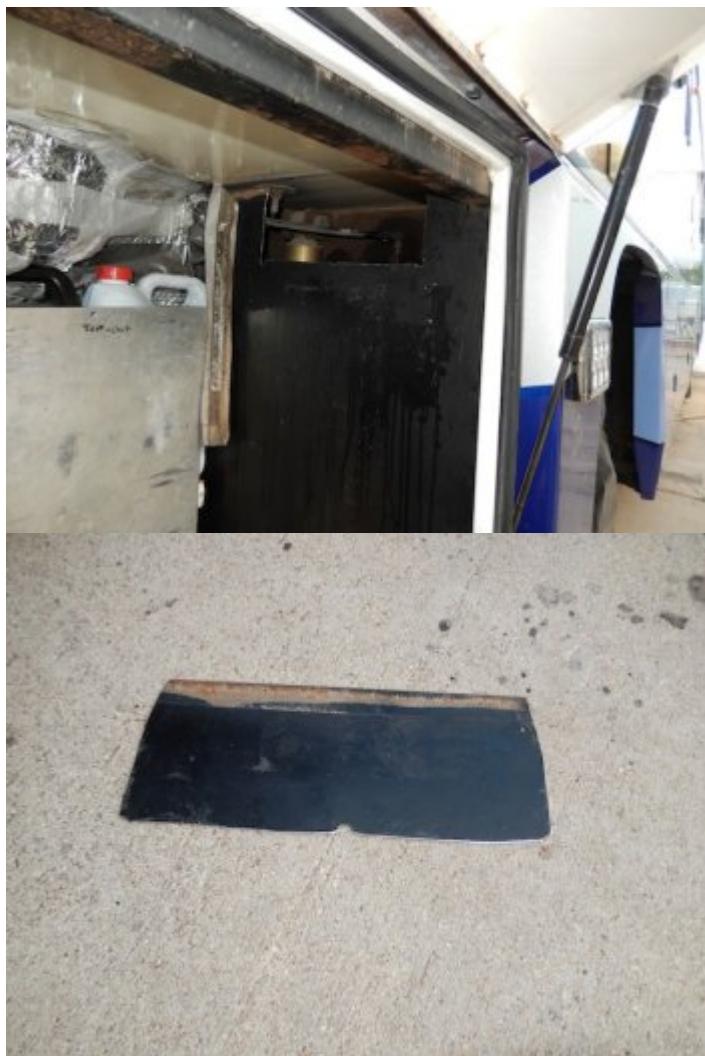
We were surprised how easily air bags could be cut with a razor knife. And cut-out pieces show that air bags are not real thick. And even though the lower outside edge of all of the old air bags have a lot of loose rubber, the damage does not show up on the inside.

Air bags have two bottom bolts and are held down to bottom round plate with reused nuts. One top fastener is exactly the same as the bottom bolts. The other top fastener is a larger diameter hollow bolt that also has an air line attached. So 32 nuts have to be removed to replace air bags.

On our coach two of the top air line bolts can be difficult to remove because they are hard to see and located in the cramped space between the side-to-side front frame and the front bulkhead. We went the extra mile, as have others, to make large holes for easy access to air line and nut.
