# 1988 thru 2005 Unibody Module/Subassembly (bulkhead) Inspection

This letter intends to clarify the process for properly inspecting the attachment points of the subassembly (sub floor) and the rear or front module of the Unihome or Unicoach chassis. The conditions addressed in this letter could pertain to year model coaches 1988 through 2005.

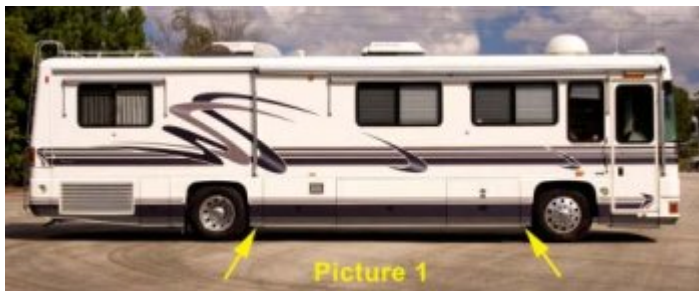
Picture 1

To inspect you will need to be able to look at the sub floor front and rear from underneath. (See Picture 1)

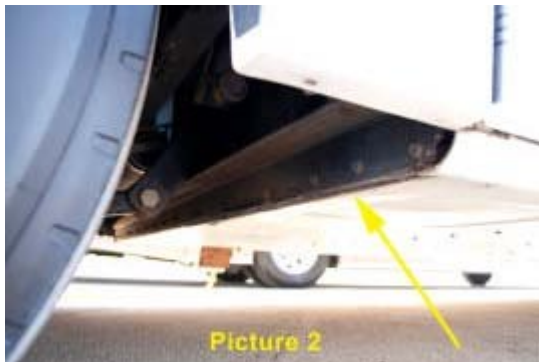
Picture 2

Inspect front and rear areas for any indication of separation of the transition seam from the front and rear module assembly to the sub floor assembly. (See Pictures 2, 3)

If there is no evidence of rust, separation or missing fasteners, you will want to continue to inspect this along with your regular periodic chassis inspections at least annually or before and after extended trips.

If there is evidence of rust, seam separation or missing fasteners, it is recommended to schedule a service appointment with us here in Nacogdoches or a trusted service facility of your choosing.
