Haldex Height Control Valve (HCV) Troubleshooting Guide

[Haldex HCV Troubleshooting Guide](#)

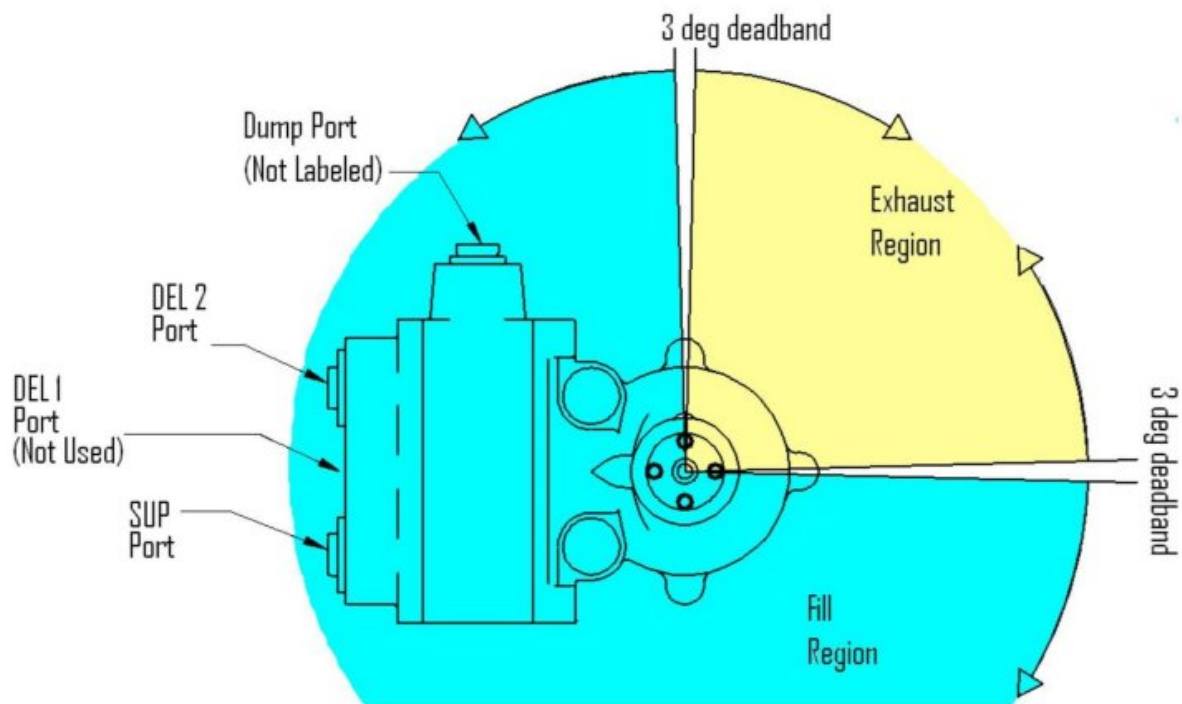
Figure 1-1

4. To ensure HCV is working properly, disconnect the linkage from the control arm and raise the control arm approximately 20 degrees above horizontal. Air pressure should inflate the air springs and raise the suspension. **Refer to Figure 1-1.**
 1. If the air springs do not inflate:

5. If HCV properly inflates the air springs, rotate the control arm down approximately 20° below horizontal. During normal operation the air is exhausted from underneath the interface cap of the valve.

2. Verify proper Drive Collar Indicator Orientation & Flow Paths (Refer to Figure 1-1.)

1. Rotate the control arm so the indicator is in the Exhaust Region
2. Connect a 100 psi supply pressure to the SUP port on the HCV
 1. Air should flow out from the DEL 2 port when the drive collar indicator is within the Fill Region
 2. No air should exhaust when the Drive Collar Indicator is within the Exhaust Region (can be checked using a bubble bath)
3. Connect at 100 psi supply pressure to the DEL 2 port (Keeping the SUP port connected to a 100 psi supply).
 1. Air should exhaust out from behind the Drive Collar when the indicator is within the Exhaust Region
 2. No air should exhaust when the Drive Collar Indicator is within the Fill Region (can be checked using a bubble bath).
