Haldex Height Control Valve (HCV) Troubleshooting Guide

Finding Leaks in the HCV

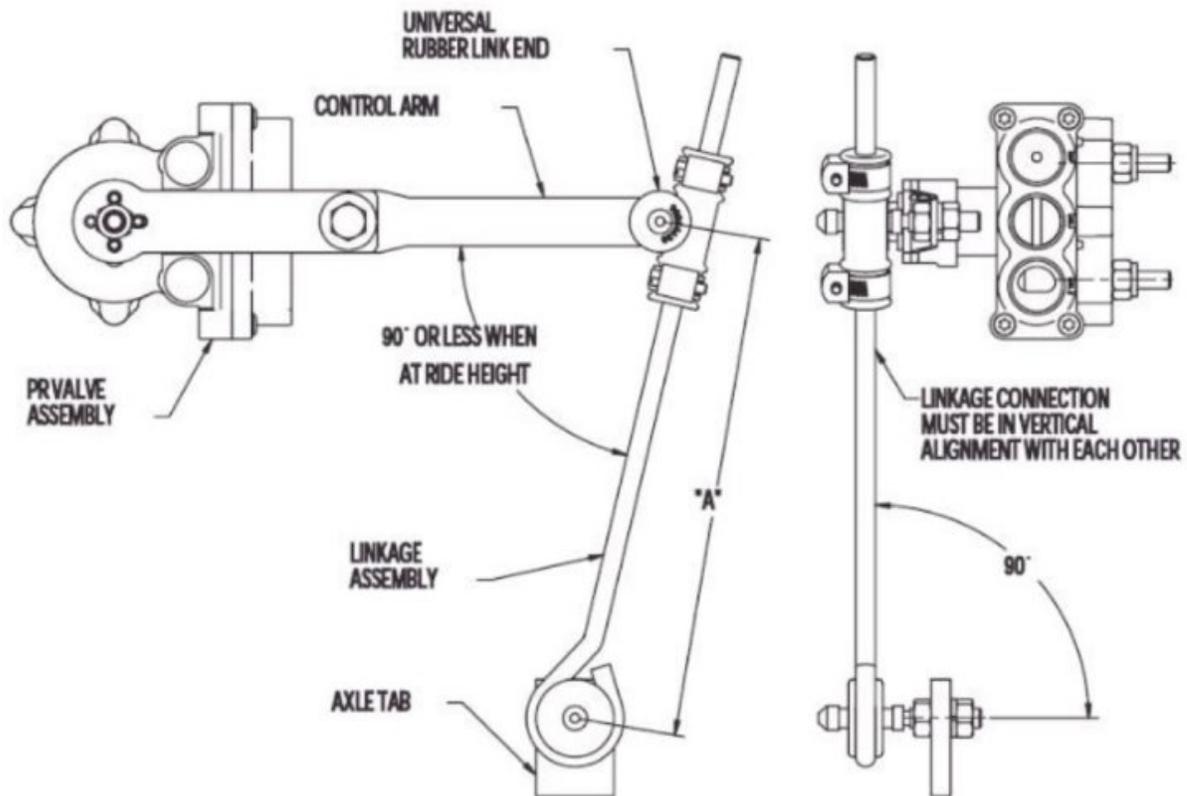
1. Determine if HCV control arm is in the proper position for installation. Alignment indicator nub should be clocked at a specific orientation which is dependent upon valve installation. All valves must be installed in accordance with Link installation instructions.
2. Make sure that the control arm and linkage are in the appropriate and recommended. Improper installation may cause damage to components of the HCV and linkage or other suspension components.

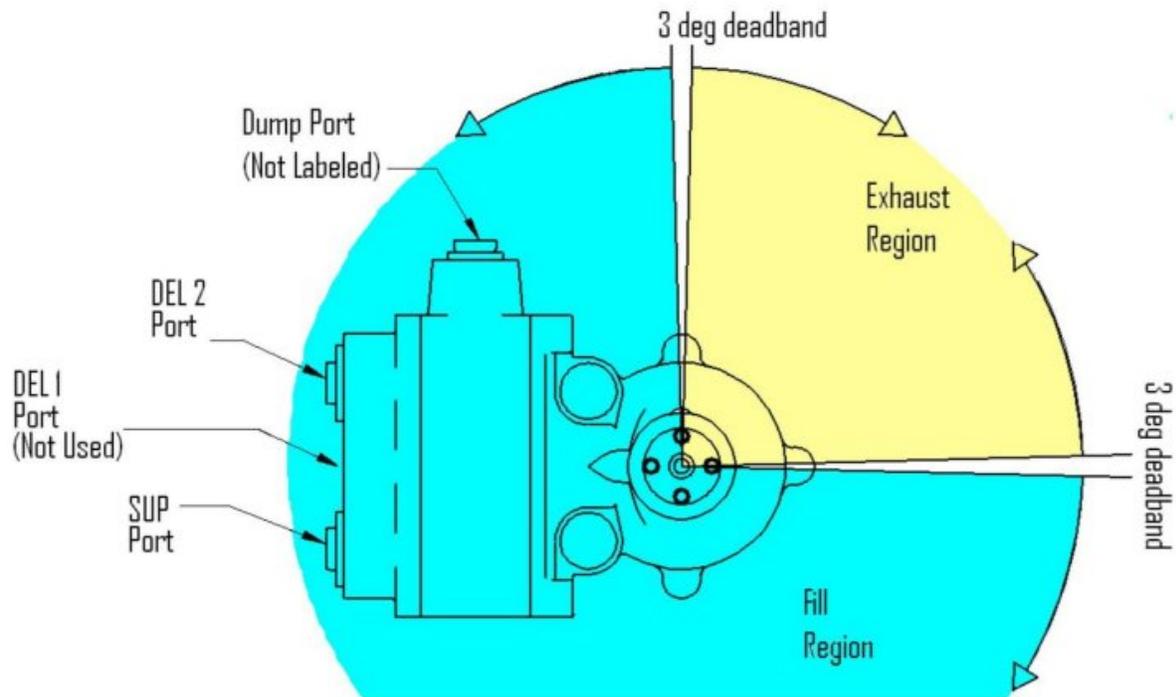
Figure 1-1

4. To ensure HCV is working properly, disconnect the linkage from the control arm and raise the control arm approximately 20 degrees above horizontal. Air pressure should inflate the air springs and raise the suspension. **Refer to Figure 1-1.**
 1. If the air springs do not inflate:

5. If HCV properly inflates the air springs, rotate the control arm down approximately 20° below horizontal. During normal operation the air is exhausted from underneath the interface cap of the valve.

2. Verify proper Drive Collar Indicator Orientation & Flow Paths (Refer to Figure 1-1.)

1. Rotate the control arm so the indicator is in the Exhaust Region
2. Connect a 100 psi supply pressure to the SUP port on the HCV
 1. Air should flow out from the DEL 2 port when the drive collar indicator is within the Fill Region
 2. No air should exhaust when the Drive Collar Indicator is within the Exhaust Region (can be checked using a bubble bath)
3. Connect at 100 psi supply pressure to the DEL 2 port (Keeping the SUP port connected to a 100 psi supply).
 1. Air should exhaust out from behind the Drive Collar when the indicator is within the Exhaust Region
 2. No air should exhaust when the Drive Collar Indicator is within the Fill Region (can be checked using a bubble bath).
