Haldex Height Control Valve (HCV) Troubleshooting Guide

[Haldex HCV Troubleshooting Guide](#)

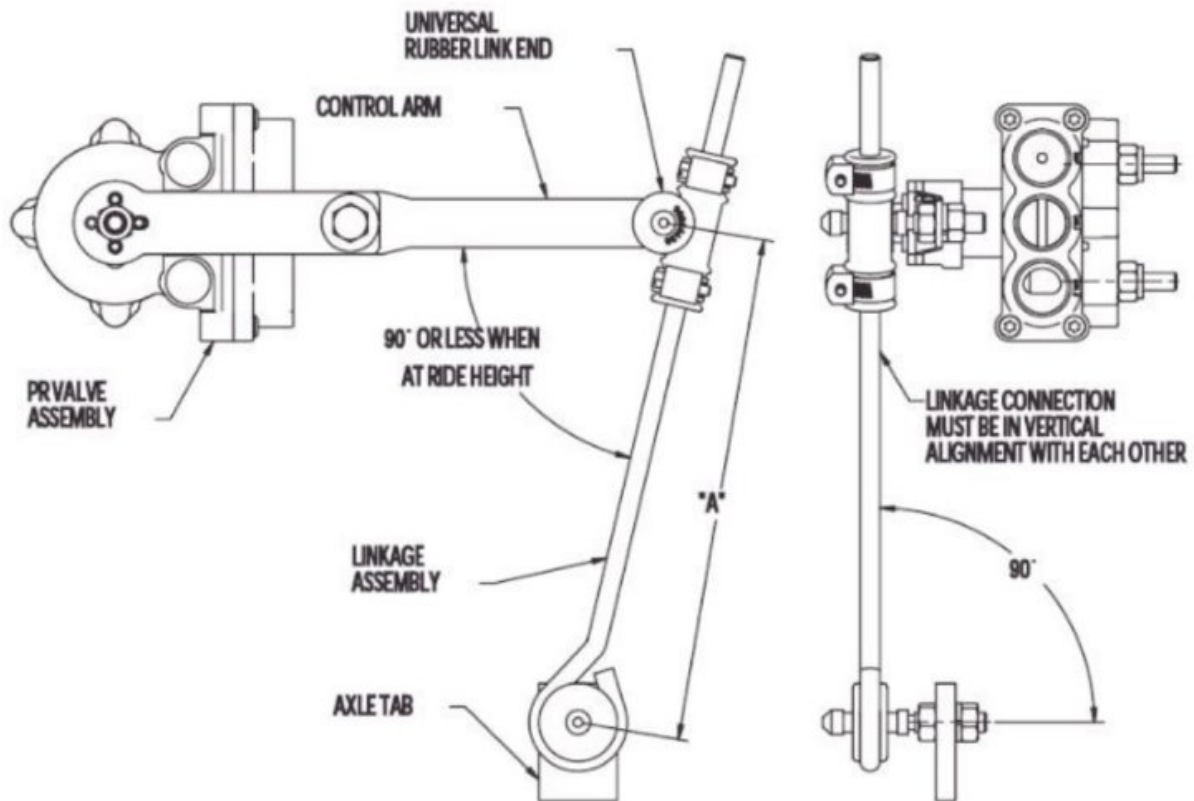
1. Determine if HCV control arm is in the proper position for installation. Alignment indicator nub should be clocked at a specific orientation which is dependent upon valve installation. All valves must be installed in accordance with Link installation instructions.
2. Make sure that the control arm and linkage are in the appropriate and recommended. Improper installation may cause damage to components of the HCV and linkage or other suspension components.

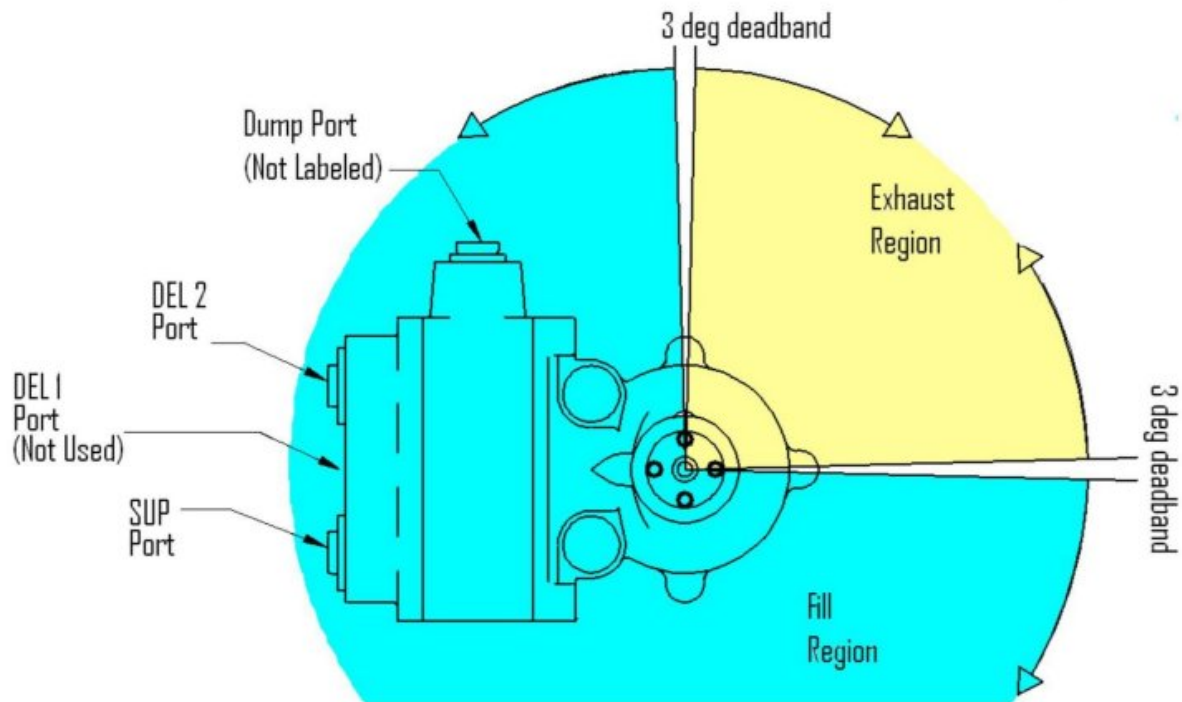
Figure 1-1

4. To ensure HCV is working properly, disconnect the linkage from the control arm and raise the control arm approximately 20 degrees above horizontal. Air pressure should inflate the air springs and raise the suspension. **Refer to Figure 1-1.**
 1. If the air springs do not inflate:

5. If HCV properly inflates the air springs, rotate the control arm down approximately 20° below horizontal. During normal operation the air is exhausted from underneath the interface cap of the valve.

2. Verify proper Drive Collar Indicator Orientation & Flow Paths (Refer to Figure 1-1.)

1. Rotate the control arm so the indicator is in the Exhaust Region
2. Connect a 100 psi supply pressure to the SUP port on the HCV
 1. Air should flow out from the DEL 2 port when the drive collar indicator is within the Fill Region
 2. No air should exhaust when the Drive Collar Indicator is within the Exhaust Region (can be checked using a bubble bath)
3. Connect at 100 psi supply pressure to the DEL 2 port (Keeping the SUP port connected to a 100 psi supply).
 1. Air should exhaust out from behind the Drive Collar when the indicator is within the Exhaust Region
 2. No air should exhaust when the Drive Collar Indicator is within the Fill Region (can be checked using a bubble bath).
