## Retarder plate leak

by **Michael and Jackie**

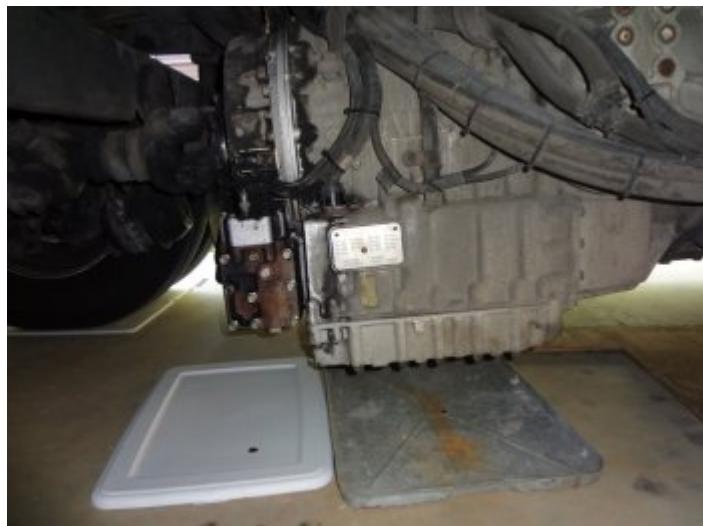
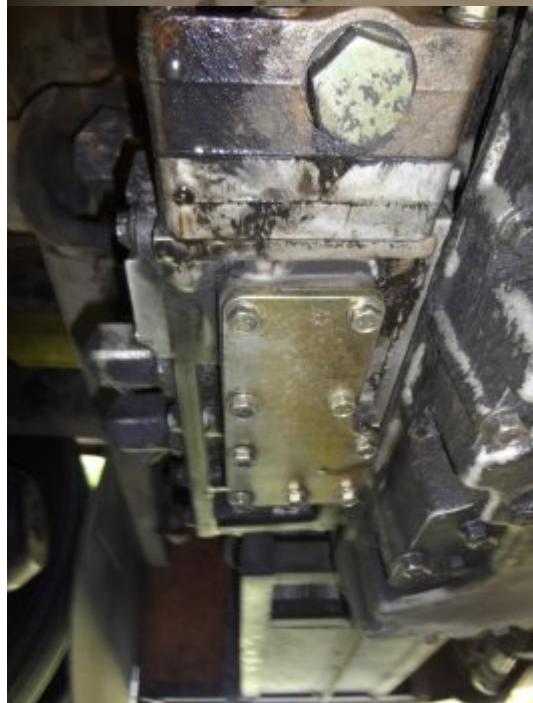
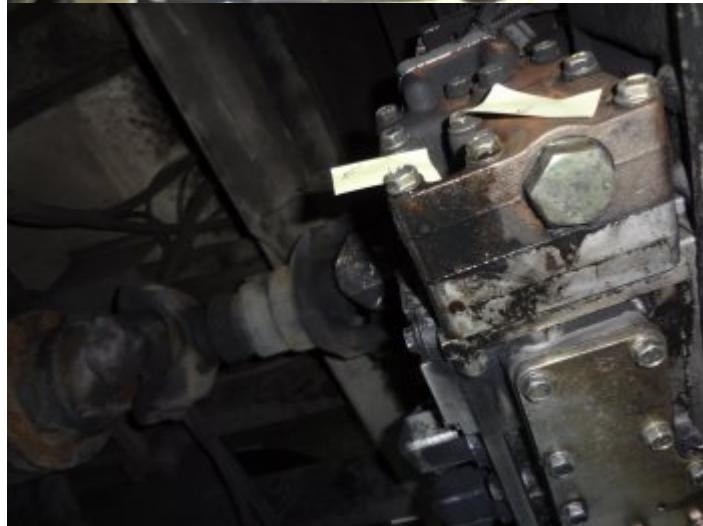
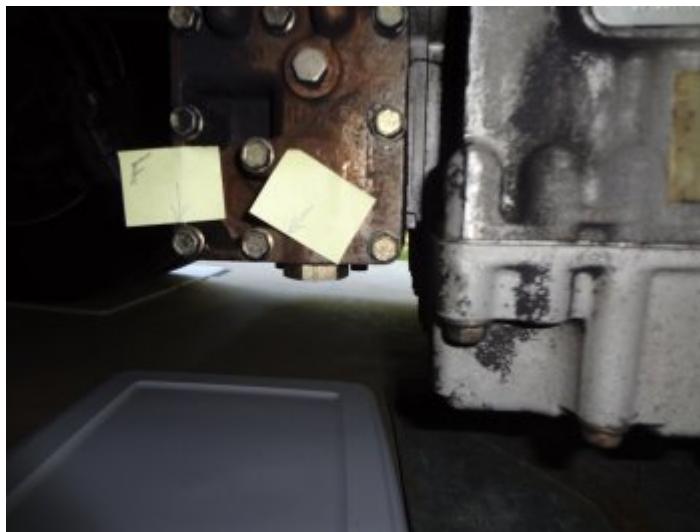
I noticed an occasional small drop of "oil" on the floor beneath the back of the transmission. It concerned me so I had mechanics and technicians look at it. I had checked fluid level, no detected loss.

MOT checked and found nine bolts at about one quarter the spec torque required so they tightened them to specs. They then soaped and pressure cleaned the tranny, I drove and then crawled under several times to monitor the clean surfaces. The fluid seep around two bolts was visible, the tightening did not solve. Maybe more than the two bolts were involved, there are quite a few more than nine there.

Took the coach to Stewart and Stevenson. When I got there, about 100 miles, and parked, we noted the leak had increased from a drop or two, so timely to have looked at this. S&S took it apart and found three gaskets of the retarder plates needing to be replaced. Maybe it would have continued many miles just leaking a little but that would have worried me.

Maybe check these every, oh, 140,000 miles? Mike
