# Retarder plate leak

by **Michael and Jackie**

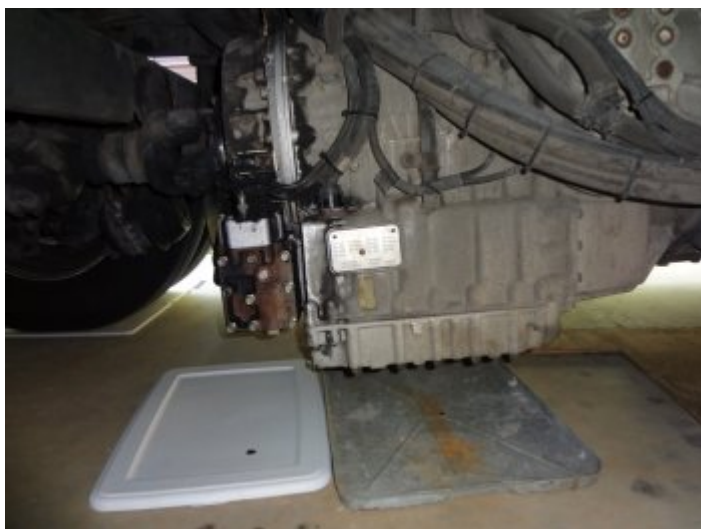
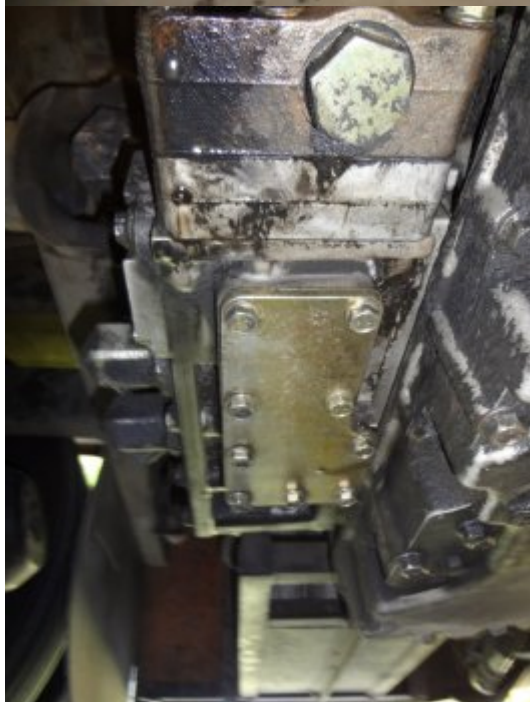
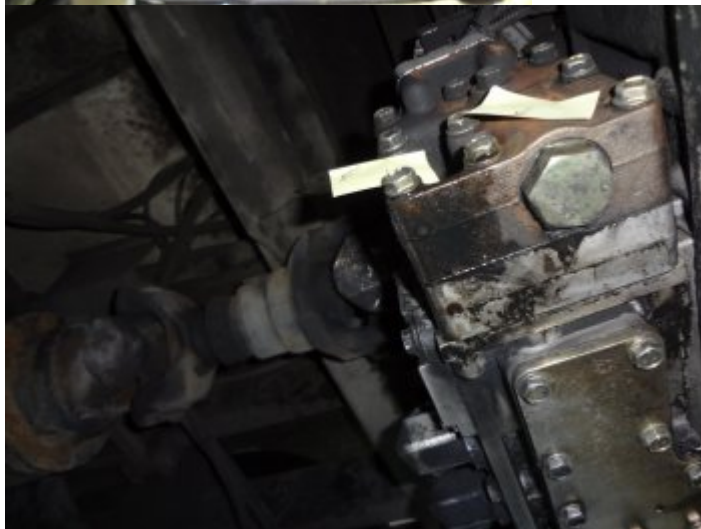
MOT checked and found nine bolts at about one quarter the spec torque required so they tightened them to specs. They then soaped and pressure cleaned the tranny, I drove and then crawled under several times to monitor the clean surfaces. The fluid seep around two bolts was visible, the tightening did not solve. Maybe more than the two bolts were involved, there are quite a few more than nine there.

Took the coach to Stewart and Stevenson. When I got there, about 100 miles, and parked, we noted the leak had increased from a drop or two, so timely to have looked at this. S&S took it apart and found three gaskets of the retarder plates needing to be replaced. Maybe it would have continued many miles just leaking a little but that would have worried me.
