Retarder plate leak

by **Michael and Jackie**

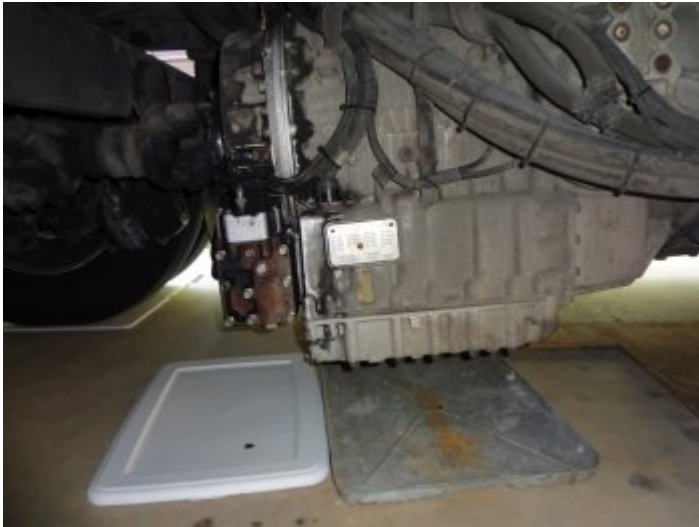
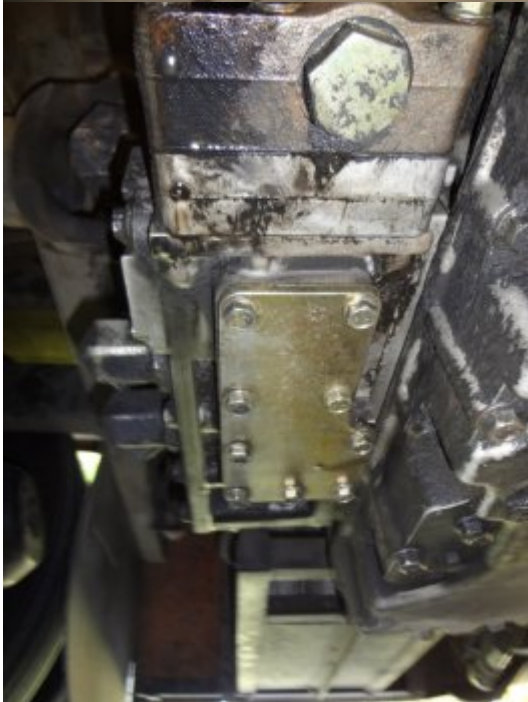
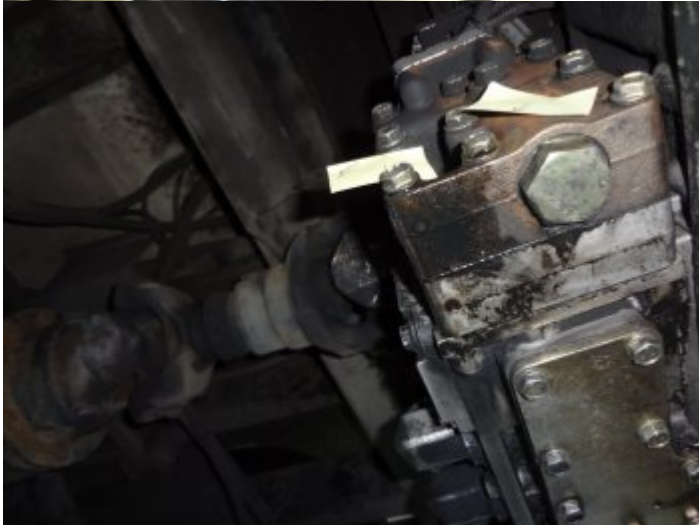
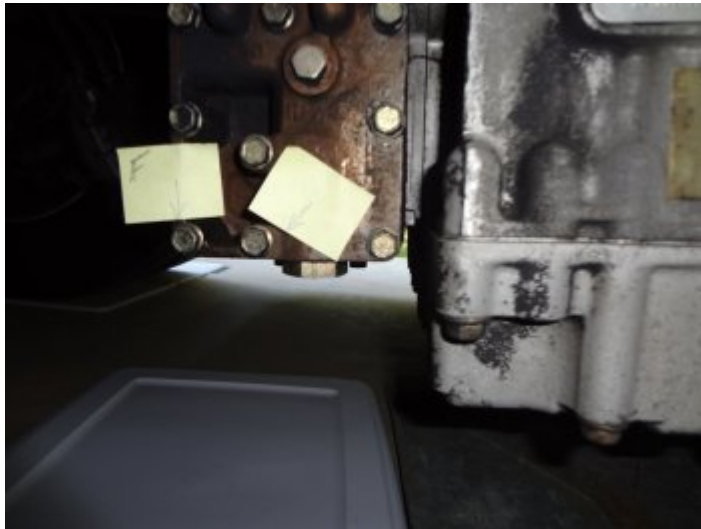
I noticed an occasional small drop of “oil” on the floor beneath the back of the transmission. It concerned me so I had mechanics and technicians look at it. I had checked fluid level, no detected loss.

MOT checked and found nine bolts at about one quarter the spec torque required so they tightened them to specs. They then soaped and pressure cleaned the tranny, I drove and then crawled under several times to monitor the clean surfaces. The fluid seep around two bolts was visible, the tightening did not solve. Maybe more than the two bolts were involved, there are quite a few more than nine there.

Took the coach to Stewart and Stevenson. When I got there, about 100 miles, and parked, we noted the leak had increased from a drop or two, so timely to have looked at this. S&S took it apart and found three gaskets of the retarder plates needing to be replaced. Maybe it would have continued many miles just leaking a little but that would have worried me.

Maybe check these every, oh, 140,000 miles? Mike
