Retarder Accumulator Bracket Failure

Foretravel has become aware of an issue where a weld on the transmission retarder accumulator mounting bracket may fail due to bracket damage or fatigue. The only **affected coaches are year model 1998 through 2007 with 450 or 500 hp Cummins M11 or ISM engines** having the retarder accumulator mounted to the engine bell housing.

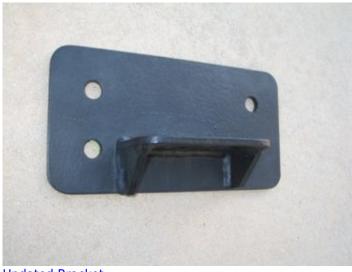
Updated Bracket

If non-warrantable replacement is needed the bracket (Part # P23439SVC) can be ordered directly from Foretravel Parts Dept. The approximate retail price of the bracket is \$67.00. It will take approximately 45 minutes to replace. The customer will be responsible for non-warrantable replacement parts and labor.

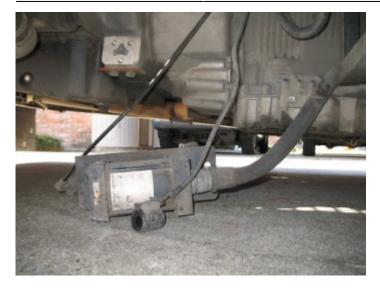
Bracket and Solenoid pieces dragging under coach. Also shows location of bracket attachment location above

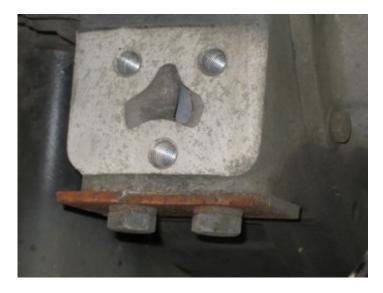
You should be able to see how easy this would be able to spot via inspection.

When these particular coaches are being serviced in your shop the bracket should be inspected for cracking or damage in the bottom weld area. It will take less than 15 minutes to inspect. As a courtesy, Foretravel will provide the inspection at no charge to the customer in your shop. If there are signs that the bracket should be replaced, and the coach is under warranty, Foretravel will supply a new mounting bracket and labor to replace at no charge to the customer. Call Foretravel Technical Services (936) 564-8367, extension 259 or 237 for prior approval before replacing bracket.

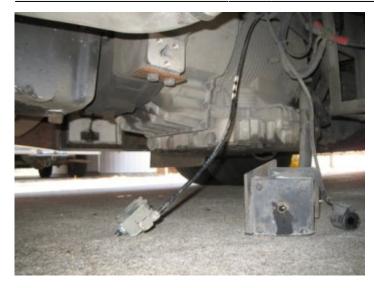
A better perspective of location of bracket.

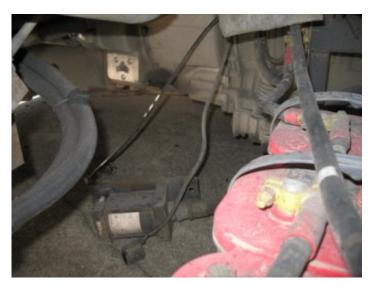
From the engine battery access door on curb side

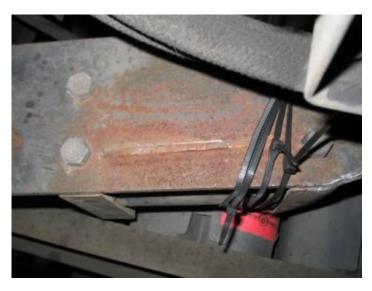
Shows where the metal fractured
