Replacing transmission retarder valve

Allison Part #29552377 (this replaces earlier part #29547934)

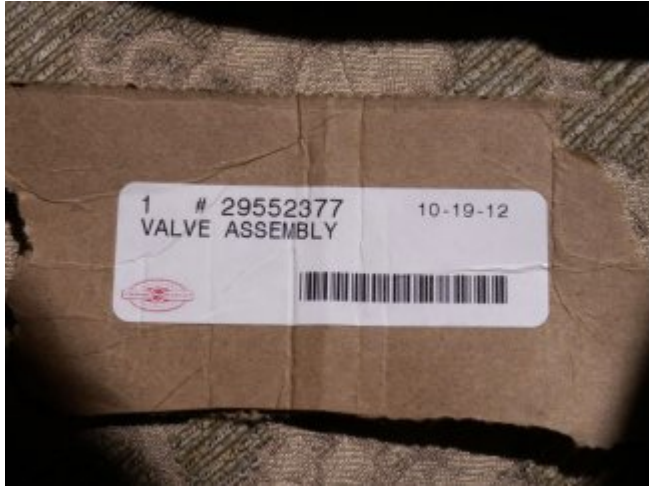
The Foretravel shop reported our retarder valve assembly was leaking quite a lot air. We decided not to replace it due to cost and advice from Alton that it probably was not necessary. The part, which they had in stock, was \$500.03.

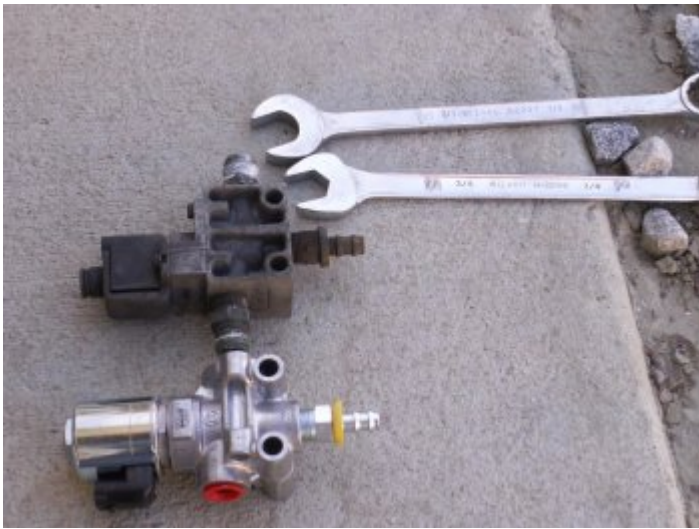
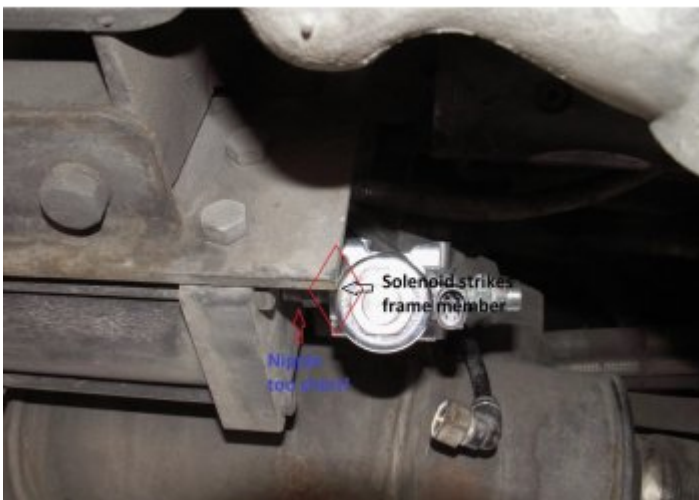
The solenoid on the new assembly is a little wider than on the old one Part #29522717. As a result, reusing the old nipple did not work. I had to get something longer. Found a 3/8" x 2" nipple at the local auto parts store, which worked fine.

Then remove valve from retarder accumulator.
Hardest part was cleaning old pipe compound from hardware threads.
